Tree Inventory and Arborist Report

5688 Main St, Whitchurch-Stouffville, ON L4A 7Z9

Tree Inventory – 5688 Main Street, Whitchurch-Stouffville ON L4A 2T1 – April 5 2024.

**TREE INVENTORY,
PRESERVATION &
REMOVALS PLAN**

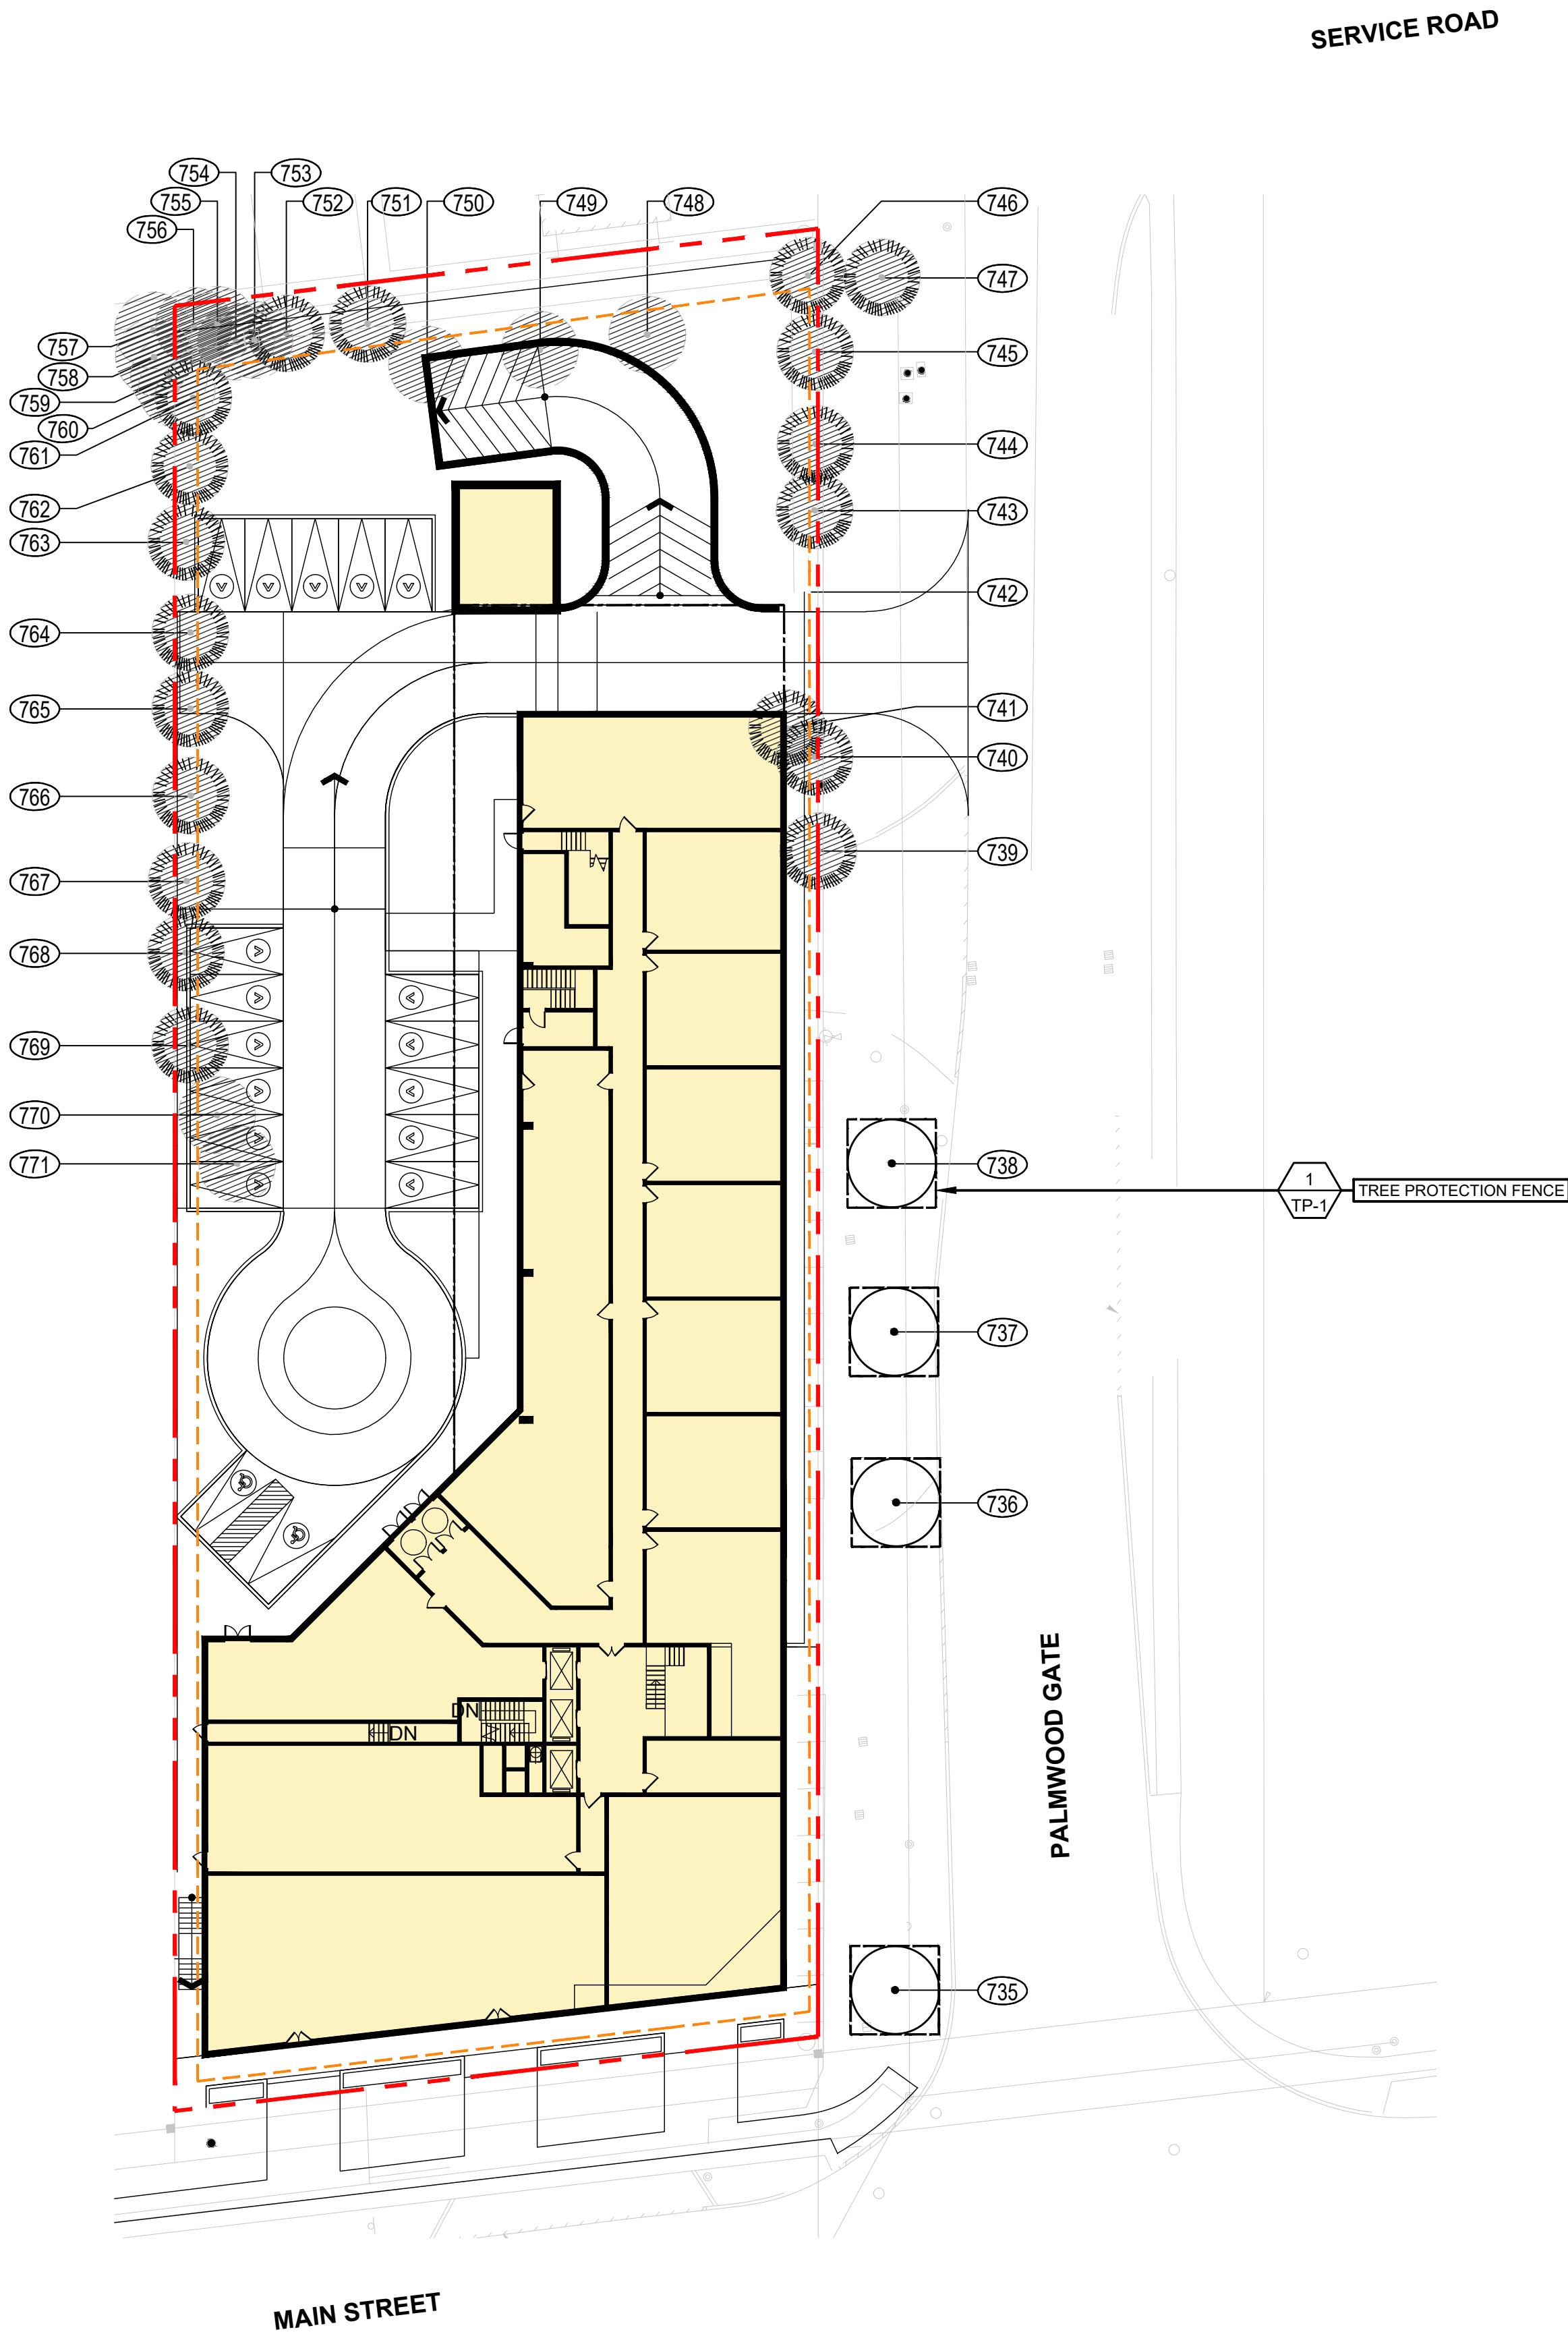
drawn by ZC	reviewed by JS	drawing number: TP-1
date 24/02/08	scale 1:300

Tree Inventory – 5688 Main Street, Whitchurch-Stouffville ON L4A 2T1 – April 5 2024.												
Tag #	Common Name	Botanical Name	Diameter at Breast Height (cm)				Health Condition	Structural Condition	Notes	Recommendations Based on Site Plan	Minimum TPZ (m)	
735	Honey Locust	Gleditsia triacanthos	31	x	30	x	23	Fair	Fair	Pruned for hydro above.	Preserve & Protect	2.4
736	Honey Locust	Gleditsia triacanthos	37					Fair	Fair		Preserve & Protect	2.4
737	Honey Locust	Gleditsia triacanthos	33					Fair	Fair		Preserve & Protect	2.4
738	Honey Locust	Gleditsia triacanthos	38					Fair	Fair		Preserve & Protect	2.4
739	Norway Spruce	Picea abies	30					Fair/Poor	Fair	Significant dead wood, close to entrance gate.	Remove	2.4
740	Norway Spruce	Picea abies	36					Good	Good		Remove	2.4
741	Norway Spruce	Picea abies	40					Good	Good		Remove	2.4
742	Norway Spruce	Picea abies	37					Good	Good		Remove	2.4
743	Norway Spruce	Picea abies	23	x	29			Good	Fair/Poor	Co-dominant stems with included bark.	Remove	1.8

744	Norway Spruce	Picea abies	49					Good	Good		Remove	3
745	Norway Spruce	Picea abies	53					Good	Good		Remove	3.6
746	Norway Spruce	Picea abies	41					Good	Good		Remove	3
747	White Mulberry	Morus alba	12	x	9	x	4	Fair	Fair	Grown underneath Spruce row. ADDED TO SURVEY FOR REF.	Remove	1.2
748	Silver Maple	Acer saccharinum	72					Fair	Fair		Remove	4.8
749	Silver Maple	Acer saccharinum	80					Good	Fair		Remove	4.8
750	Silver Maple	Acer saccharinum	68					Good	Fair		Remove	4.2
751	Norway Spruce	Picea abies	37					Good	Good	No tag. Behind sheds and behind fence.	Remove	2.4
752	Norway Spruce	Picea abies	30					Fair	Fair	Crowded canopy	Remove	2.4
753	Norway Maple	Acer platanoides	30					Fair	Fair/Poor	Grown in fence.	Remove	2.4
754	Norway Maple	Acer platanoides	30					Fair	Poor	Grown in fence.	Remove	2.4
755	Norway Maple	Acer platanoides	18					Fair	Fair	ADDED TO SURVEY FOR REF.	Remove	1.8
756	Norway Maple	Acer platanoides	20					Fair	Fair	No tag, in between 2 fences. ADDED TO SURVEY FOR REF.	Remove	1.8

757	Norway Maple	Acer platanoides	22					Fair	Fair	No tag, in between 2 fences. ADDED TO SURVEY FOR REF.	Remove	1.8
758	Norway Spruce	Picea abies	16					Fair/Poor	Fair/Poor	No tag, behind fence, sparse foliage due to competing growth. ADDED TO SURVEY FOR REF.	Remove	1.8
759	Norway Maple	Acer platanoides	28					Fair	Fair	No tag, along fence.	Remove	1.8
760	Norway Maple	Acer platanoides	28					Good	Good	No tag, behind fence. ADDED TO SURVEY FOR REF.	Remove	1.8
761	Norway Spruce	Picea abies	28					Fair	Fair	Lower deadwood.	Remove	1.8
762	Norway Spruce	Picea abies	28	x	20			Fair	Fair/Poor	Co-dominant	Remove	1.8
763	Norway Spruce	Picea abies	45					Good	Good		Remove	3
764	Norway Spruce	Picea abies	33					Good	Good		Remove	2.4
765	Norway Spruce	Picea abies	45					Good	Good		Remove	3
766	Norway Spruce	Picea abies	36					Good	Good	Lower branches pruned away from building ADDED TO SURVEY FOR REF.	Remove	2.4

767	Norway Spruce	Picea abies	45					Good	Good	Lower branches pruned away from building	Remove	3
768	Norway Spruce	Picea abies	31					Good	Good	Lower branches pruned away from building	Remove	2.4
769	Norway Spruce	Picea abies	19					Good	Good		Remove	1.8
770	Silver Maple	Acer saccharinum	90					Good	Fair	Cavity on one side where previous branch was.	Remove	5.4
771	Silver Maple	Acer saccharinum	86					Good	Fair		Remove	5.4

TOTAL # OF TREES INVENTORIED = 37
TOTAL # OF TREES TO BE REMOVED = 33
TOTAL # OF TREES TO REMAIN = 4
