# TREE INVENTORY AND ASSESSMENT REPORT

## FARSIGHT HOMES - LAKESHORE ROAD

### BALLANTRAE, ON

**April 6, 2021**  
SCI Project No. 16050

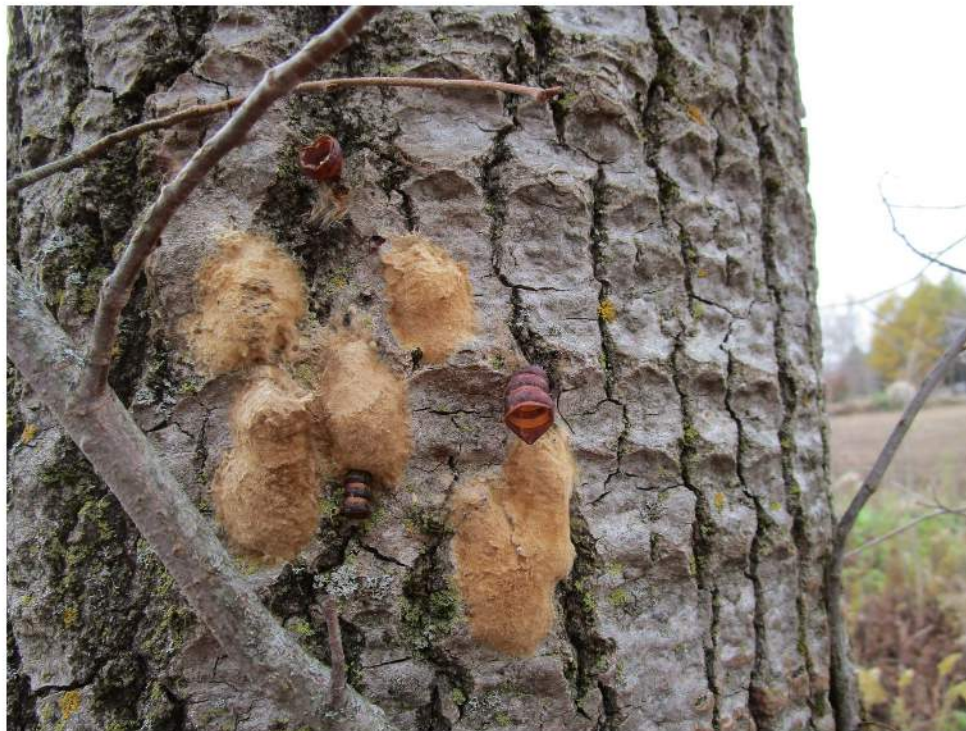
It was noted that many of the trees that are located within the Study Area are affected by the presence of Gypsy Moth (*Lymantria dispar dispar*). Gypsy Moth is an invasive species in Ontario, native to Europe and Asia. It is a forest defoliating insect that feed on the leaves of various tree species. Gypsy Moth eggs & old cocoons were evident on 11.11% (44 total) of trees that were inventoried, most of which were Trembling Aspen *Populus tremuloides*, Black Cherry *Prunus serotina* and Paper Birch *Betula papyrifera*. Refer to the Tree Inventory & Assessment Matrix, Appendix “A” for all individually assessed trees that were affected by Gypsy Moth.

**FIGURE 2 – Gypsy Moth (*Lymantria dispar dispar*) Egg Masses & Cocoons on Poplar Tree**

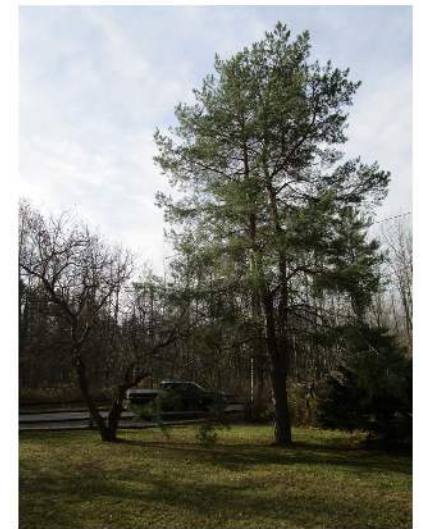
Trees 9 - 10

| Tree No. | Tag No. | Species | | Condition | | DBH (single stem)** | DBH Range of Multi-stemmed Trees (# of Stems) | Ownership Categories **** | Notes | Recommendations* |
|---|---|---|---|---|---|---|---|---|---|---|
| 10 | 1009 | Malus sp. | Apple Species | Fair | Good | - | 33.0 - 21.0 (2) | Private 1 | Codominant stems, failed limb, sprout growth | A |

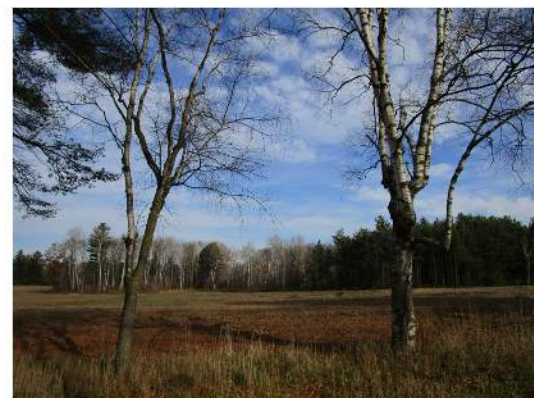
Trees 25 - 26

| Tree No. | Tag No. | Species | | Condition | | DBH (single stem)** | DBH Range of Multi-stemmed Trees (# of Stems) | Ownership Categories **** | Notes | Recommendations* |
|---|---|---|---|---|---|---|---|---|---|---|
| 26 | 1025 | Betula papyrifera | Paper Birch | Fair | Poor | 43.5 | - | Private 1 | Frost crack on trunk | B |

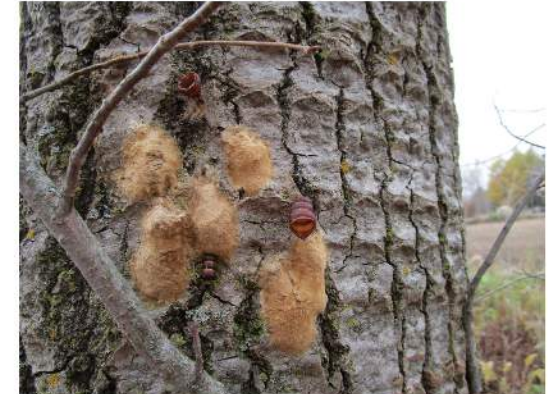
Tree 116 - gypsy moth eggs & cocoons

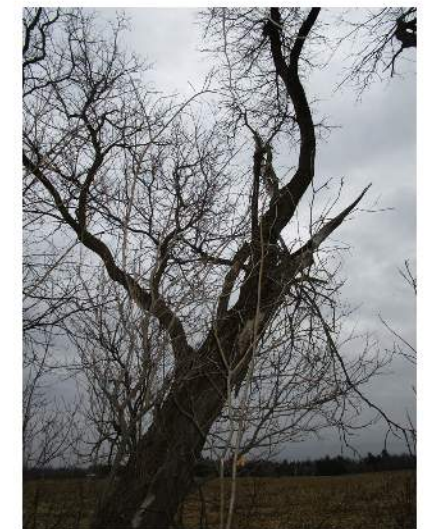
Tree 371

| Tree No. | Tag No. | Species | | Condition | | DBH (single stem)** | DBH Range of Multi-stemmed Trees (# of Stems) | Ownership Categories **** | Notes | Recommendations* |
|---|---|---|---|---|---|---|---|---|---|---|
| 371 | 1302 | Acer negundo | Manitoba Maple | Poor | Poor | 67.5 | - | Private 1 | Hedgerow, multiple failed limbs, lean | D |

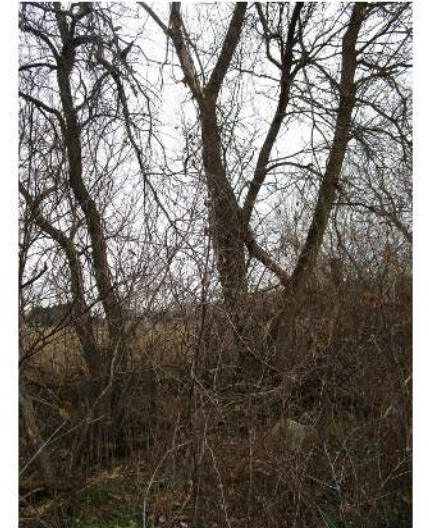
Trees 387 - 388

| Tree No. | Tag No. | Species | | Condition | | DBH (single stem)** | DBH Range of Multi-stemmed Trees (# of Stems) | Ownership Categories **** | Notes | Recommendations* |
|---|---|---|---|---|---|---|---|---|---|---|
| 387 | 1316 | Prunus serotina | Black Cherry | Poor | Poor | 23.0 | - | Private 2 | Hedgerow, dead leader, sprout production, failed limbs | B |
| 388 | 1317 | Acer negundo | Manitoba Maple | Poor | Poor | - | 45.0 - 35.5 (2) | Private 2 | Hedgerow, third stem failed, multiple failed limbs | B |

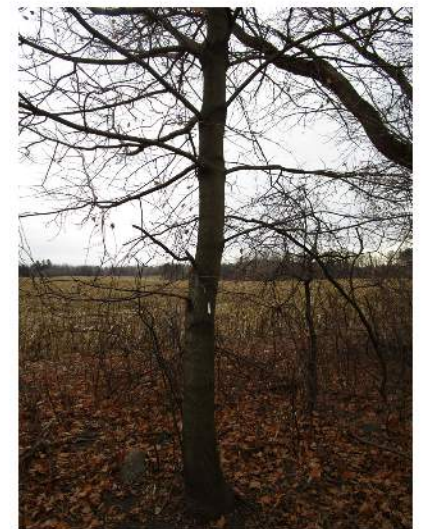
Tree 395

| Tree No. | Tag No. | Species | | Condition | | DBH (single stem)** | DBH Range of Multi-stemmed Trees (# of Stems) | Ownership Categories **** | Notes | Recommendations* |
|---|---|---|---|---|---|---|---|---|---|---|
| 395 | 1324 | Acer platanoides | Norway Maple | Good | Good | 21.5 | - | Private 1 | Hedgerow | A |
