# Tree Inventory and Arborist Report

**5688 Main St, Whitchurch-Stouffville, ON L4A 7Z9**

**February 14, 2025**

**Tree Inventory – 5688 Main Street, Whitchurch-Stouffville ON L4A 2T1 - April 5 2024.**

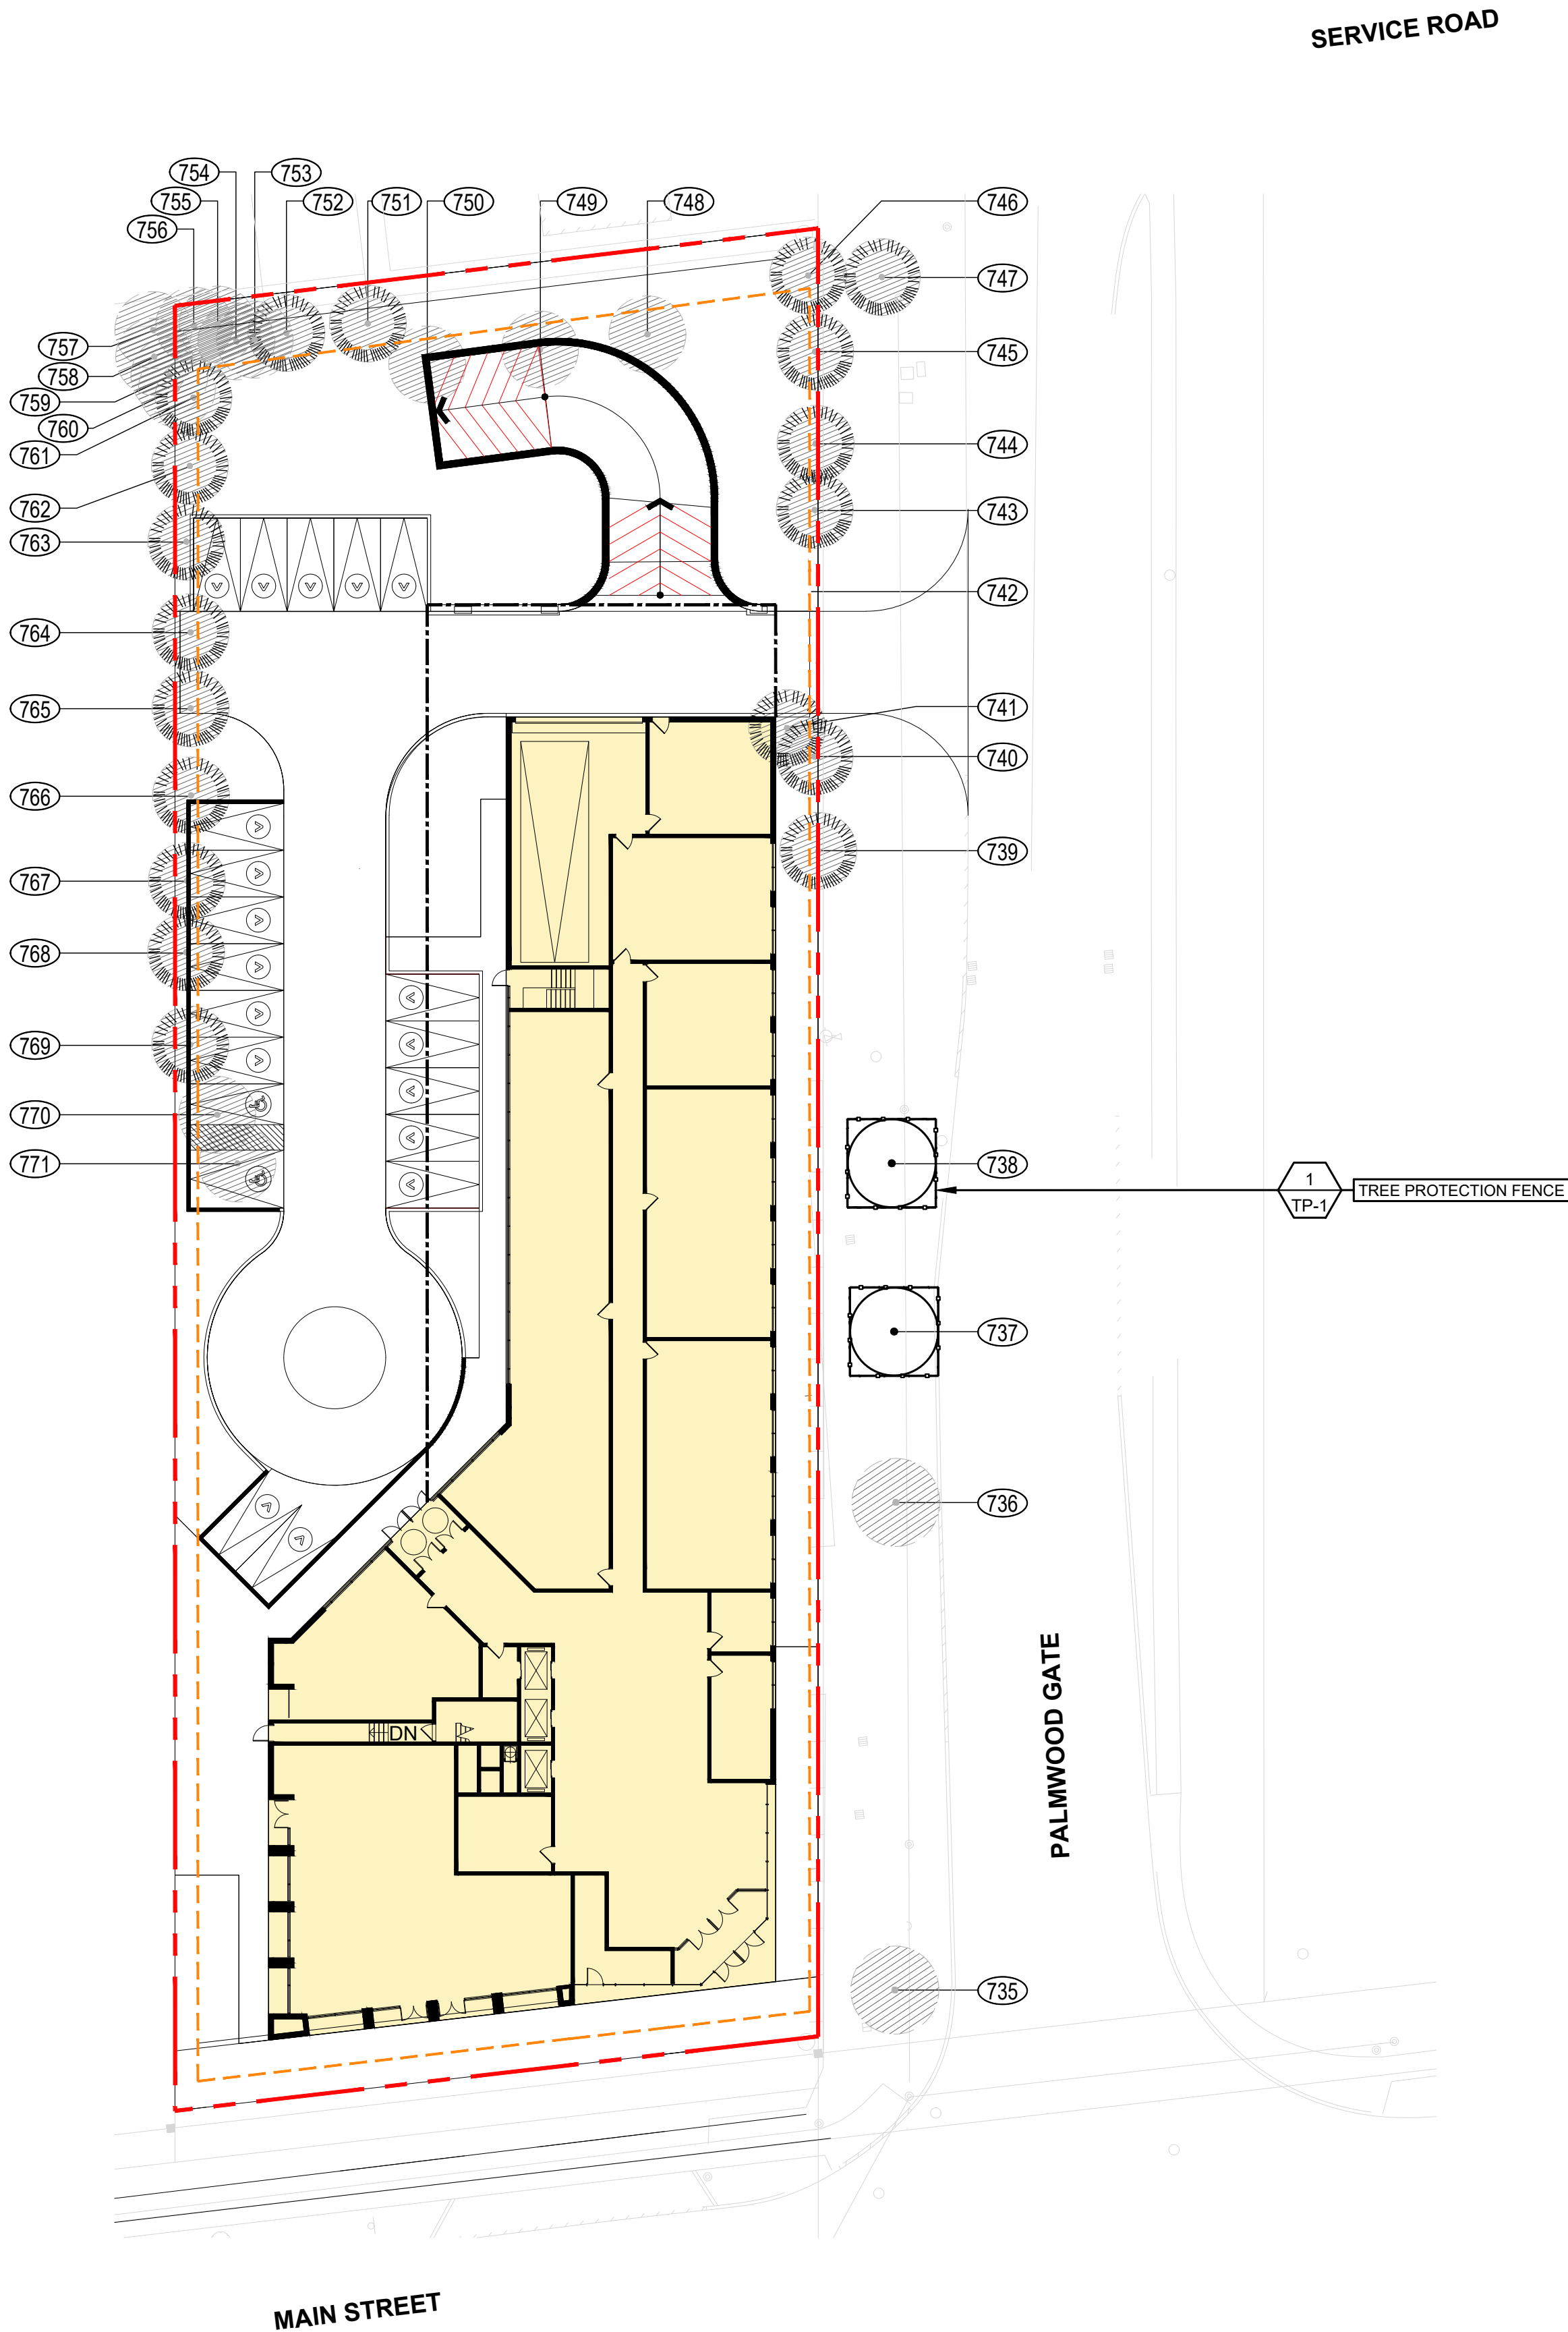
TREE INVENTORY,  
PRESERVATION &  
REMOVALS PLAN

A total of 37 trees were tagged and inventoried. There are 35 trees to be removed. A total 2 trees are to be preserved and protected. See Tree Inventory Table attached and Tree Protection Plan Drawing TP-1 by Landscape Planning Limited.
