**Tree Inventory and Preservation Plan Report  
5783 Bloomington Sideroad  
Stouffville, Ontario**

16 September 2024

KUNTZ FORESTRY CONSULTING Inc. Project P4366

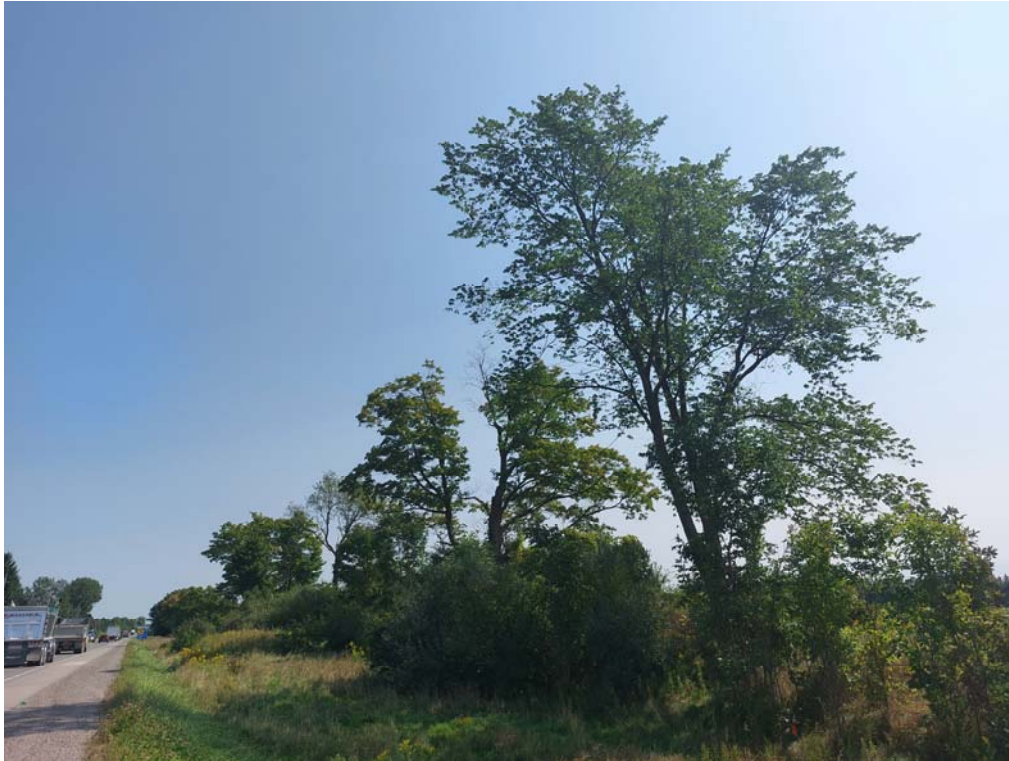
Image 1. Trees 1-6 (Right to left)

| Tree # | Common Name | Scientific Name | DBH | TI | CS | CV | YCR | DL | CDB | mTPZ | Comments | Action |
|---|---|---|---|---|---|---|---|---|---|---|---|---|
| 1 | White Elm | <i>Ulmus americana</i> | 58 | F-G | F | F-G | S | 4.5 | | 5.8 | Union at 3m, bowing (L) | Interim preservation |
| 2 | Green Ash | <i>Fraxinus pennsylvanica</i> | 3-5 | F-G | F | F | PT | 0.5 | | 2.4 | Epicormic branching | Interim preservation |
| 3 | Sugar Maple | <i>Acer saccharum</i> | 65 | P-F | F | F | Dc | 5.0 | | 6.5 | Cavities in stem (M) with rot (L), deadwood (M), union at 1.4m, poor form (L) | Interim preservation |
| 4 | Black Cherry | <i>Prunus serotina</i> | 46 | F-G | F | F-G | PT | 2.5 | | 4.6 | Union at 4.5m and 6m, poor form (L), vine competition (L) | Interim preservation |
| 5 | Sugar Maple | <i>Acer saccharum</i> | 75 | F | F | F-G | PT | 4.0 | | 7.5 | Lost leader, cavity with rot where leader lost, epicormic branching (L), deadwood (L), bowing branches (L) | Interim preservation |
| 6 | Sugar Maple | <i>Acer saccharum</i> | ~77 | F-G | F | F-G | PT | 4.0 | | 7.7 | Multiple branch attachment (L), union at 4m with included bark (M), vine competition (M) | Interim preservation |

The preservation of the remaining trees, including Trees 1-6, 8-11 and P1, will be possible with the use of appropriate tree protection measures as indicated on Figure 1. Trees 1-6 and P1 have been shown for interim preservation. It is our understanding that these trees may be impacted by works occurring on the subject property by others, outside of the proposed road widening works described in this report. Tree protection measures will have to be implemented prior to demolition to ensure tree resources designated for retention are not impacted by the development. Preservation specifications for Trees 1-6, 8-11 and P1 must conform to York Regional requirements per the NHF-series details and notes on Figure 1. Refer to Figure 1 for the location of required tree preservation fencing, general Tree Protection Plan Notes, and the tree preservation hoarding detail.

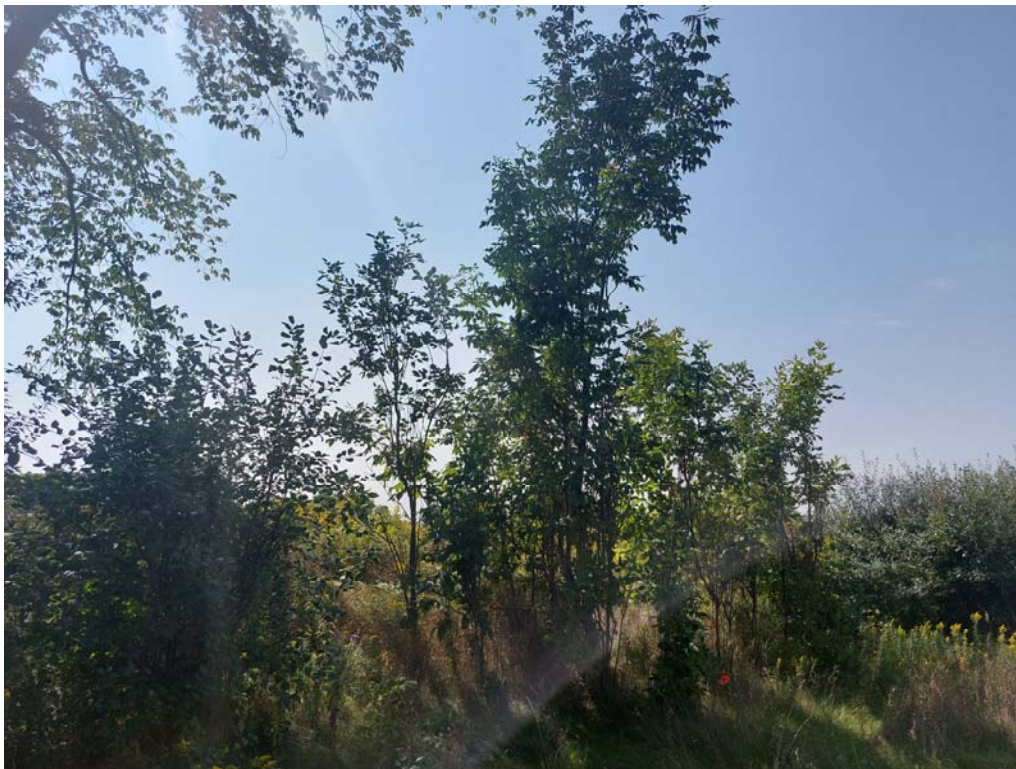
Image 2. P1

| Tree # | Common Name | Scientific Name | DBH | TI | CS | CV | YCR | DL | CDB | mTPZ | Comments | Action |
|---|---|---|---|---|---|---|---|---|---|---|---|---|
| P1 | Green Ash | <i>Fraxinus pennsylvanica</i> | 3-7 | F-G | F | F | PT | 0.5 | | 2.4 | 9 trees, epicormic branching | Interim preservation |

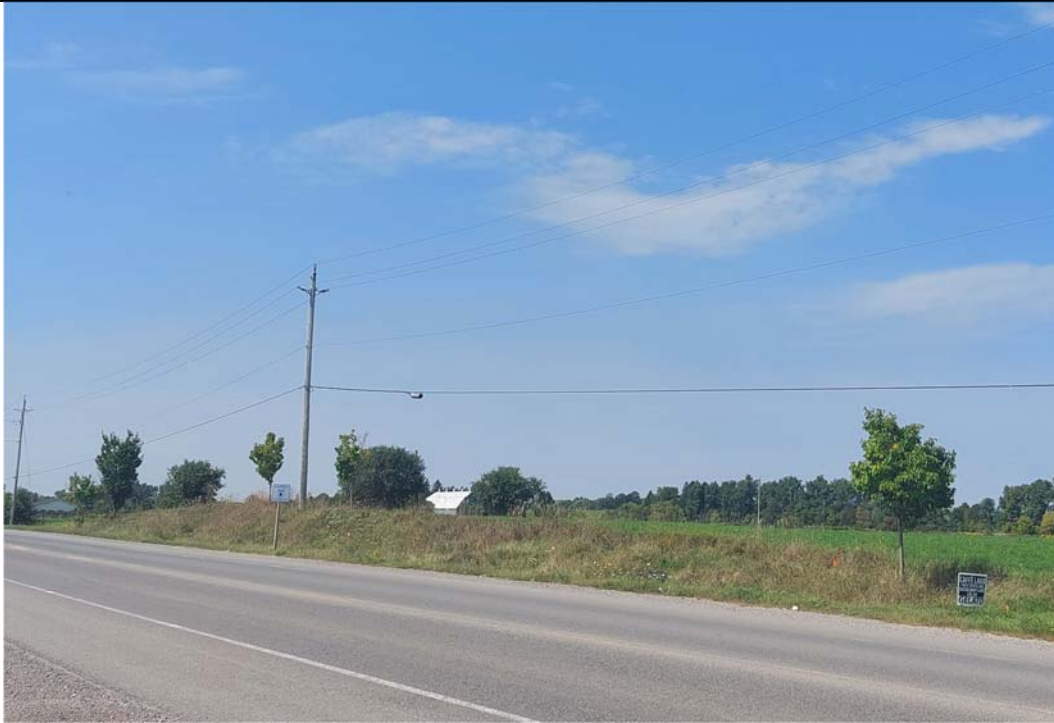
Image 3. Trees 7-11 (Right to left)

The removal of one tree, Tree 7, will be required to accommodate the proposed development. Tree 7 directly conflicts with the proposed regrading and building of the ditch.

Tree 7 is located within the road-right-of way, permission from York Region will be required prior to its removal.

| Tree # | Common Name | Scientific Name | DBH | TI | CS | CV | YCR | DL | CDB | mTPZ | Comments | Action |
|---|---|---|---|---|---|---|---|---|---|---|---|---|
| 7 | Lilac, Japanese Flowering | <i>Syringa reticulata</i> | 7 | G | G | G | G | 0.5 | | 2.4 | | Remove |
| 8 | Lilac, Japanese Flowering | <i>Syringa reticulata</i> | 6 | G | G | F | PT | 0.5 | 20 | 2.4 | Deadwood (L) | Preserve (Injure) |
| 9 | Lilac, Japanese Flowering | <i>Syringa reticulata</i> | 7 | G | G | F-G | S | 0.5 | | 2.4 | | Preserve |
| 10 | Lilac, Japanese Flowering | <i>Syringa reticulata</i> | 4-7 | F-G | F | F-G | PT | 1.0 | | 2.4 | Multistem, union at 1.1m, deadwood (VL) | Preserve |
| 11 | Lilac, Japanese Flowering | <i>Syringa reticulata</i> | 4,5,3 | F-G | F-G | G | S | 0.5 | | 2.4 | Union at 1m | Preserve |

| Tree # | Common Name | Scientific Name | DBH | Condition Rating | Owner | Action | Total DBH | DBH/50mm caliper | Number of Replacement Trees |
|---|---|---|---|---|---|---|---|---|---|
| 7 | Lilac, Japanese Flowering | <i>Syringa reticulata</i> | 7 | 0.9 | Region | Remove | 7 | 1.4 | 1.26 |

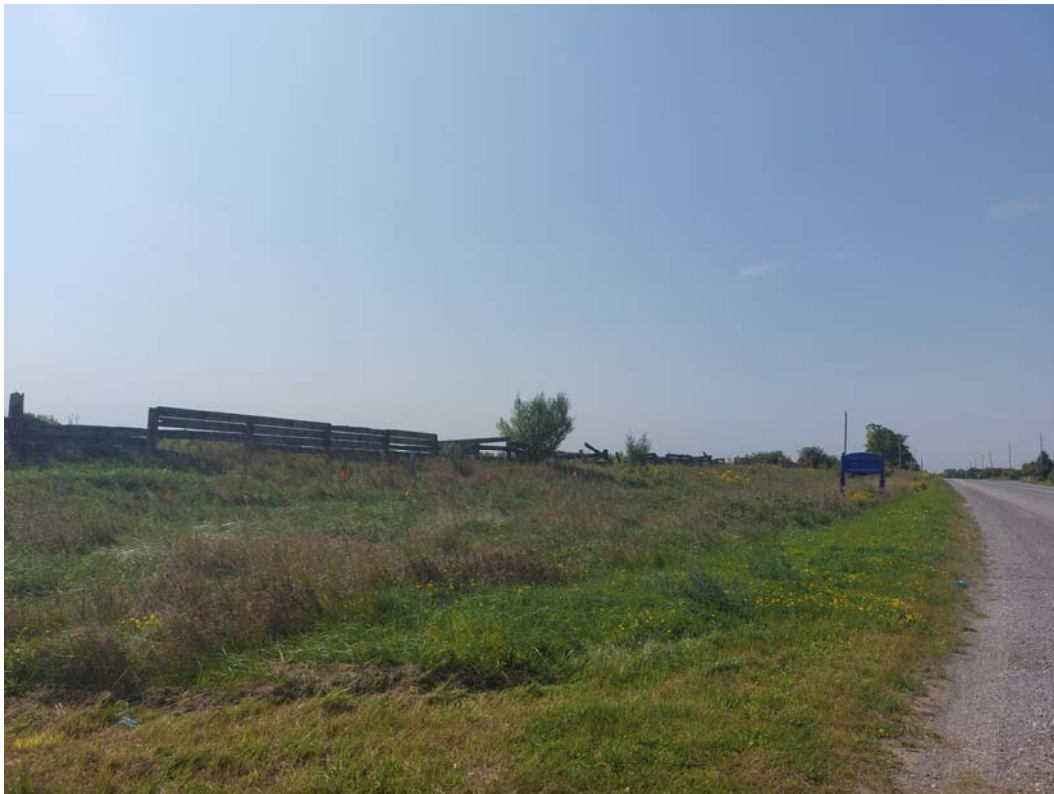
Image 4. ROW facing west on south side of Bloomington Sideroad, no trees. Shrubs present.
