Tree Inventory and Preservation Plan – Arborist Report

Elm Road (Fieldgate Developments)

Town of Whitchurch Stouffville

Date: May 29, 2025

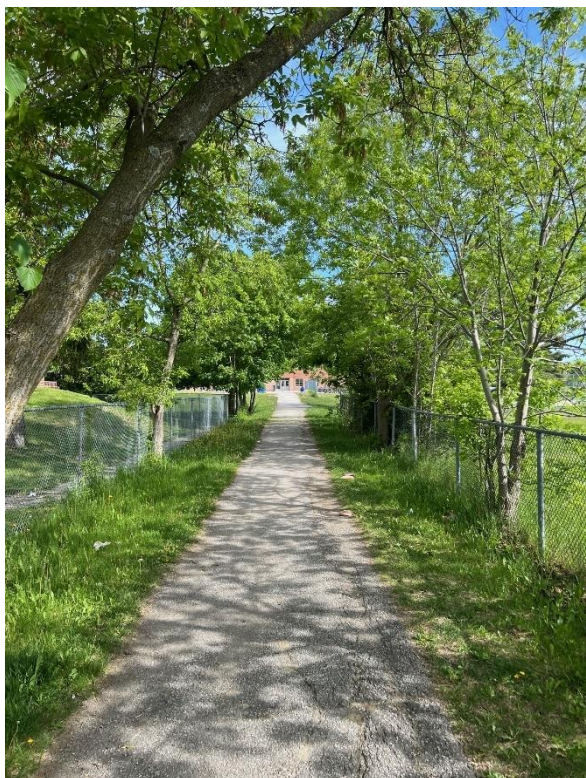
Photo # 3- Trees #28-29

To accommodate the proposed development, the removal of twelve trees will be necessary. This includes Trees #26–29, 31, 32–37, and Tree D. Trees 26–29 & 31-35 are recommended for removal due to their species and/or their location within areas that will be directly affected by grading activities. Trees 36, 37, and D are situated within the footprint of the proposed drive aisle connecting to Ninth Line, making their removal unavoidable.

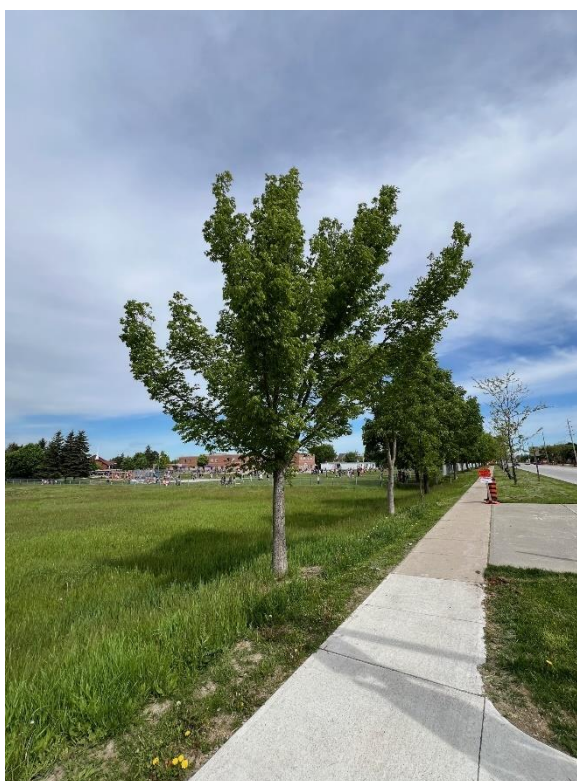
Photo # 6- Trees #32-33

The proposed development includes the removal of seven Regional Boulevard trees, (Trees # 32,33,34,35,36,37 & D). Compensation will be provided through payment by the developer. Compensation was calculated using the York Regions Street Tree and Forest Preservation Guidelines 2022. Refer to the table 2.
