# **Tree Inventory and Preservation Plan – Arborist Report**

## **Elm Road (Fieldgate Developments)**

Region's File Number SP.23.W.0113

Date: May 29, 2025 (revised Feb. 09, 2026)

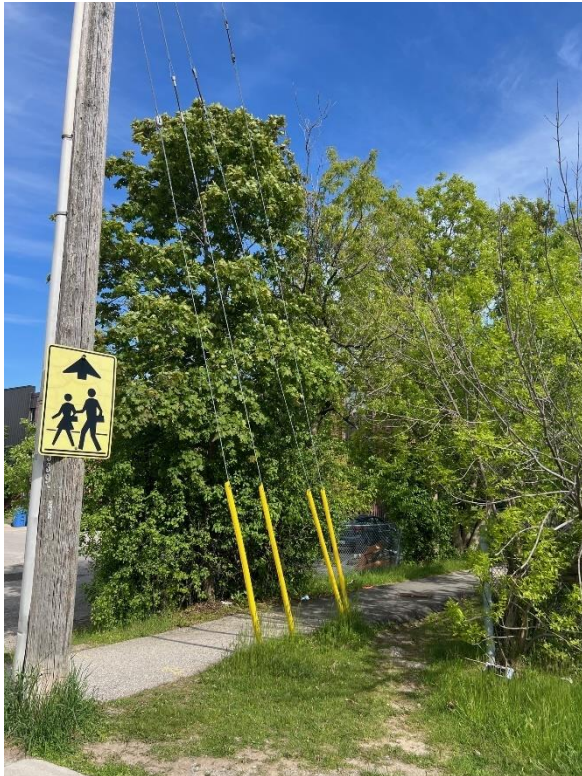
Photo #1 – Trees #20 & 30

| Tree No. | Botanical Name | Common Name | Diameter at 1.4m Height (cm) | Height (m) | Condition rating (P, F, G) | Crown Spread (m) | TPZ | Remarks | Final Tree Status (P,I,R)<br>-Preserve -<br>Injure -<br>Remove |
|---|---|---|---|---|---|---|---|---|---|
| 20 | Acer saccharum | Sugar Maple | 17 | 8 | F | 5 | 1.8 | | P |
| 30 | Acer negundo | Manitoba Maple | 22 | 7 | F | 5 | 1.8 | | P |

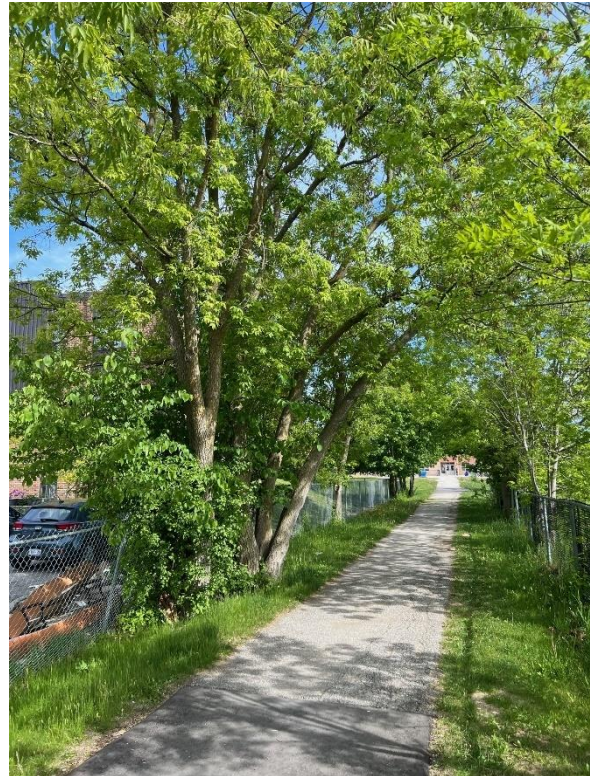
Photo # 2- Trees #21-25

| Tree No. | Botanical Name | Common Name | Diameter at 1.4m Height (cm) | Height (m) | Condition rating (P, F, G) | Crown Spread (m) | TPZ | Remarks | Final Tree Status (P,I,R)<br>-Preserve -<br>Injure -<br>Remove |
|---|---|---|---|---|---|---|---|---|---|
| 21 | Acer negundo | Manitoba Maple | 25/20 | 10 | F | 7 | 1.8 | Trunk damage at base | P |
| 22 | Acer negundo | Manitoba Maple | 27/25/25 | 10 | F | 9 | 1.8 | Leaning to the east | P |

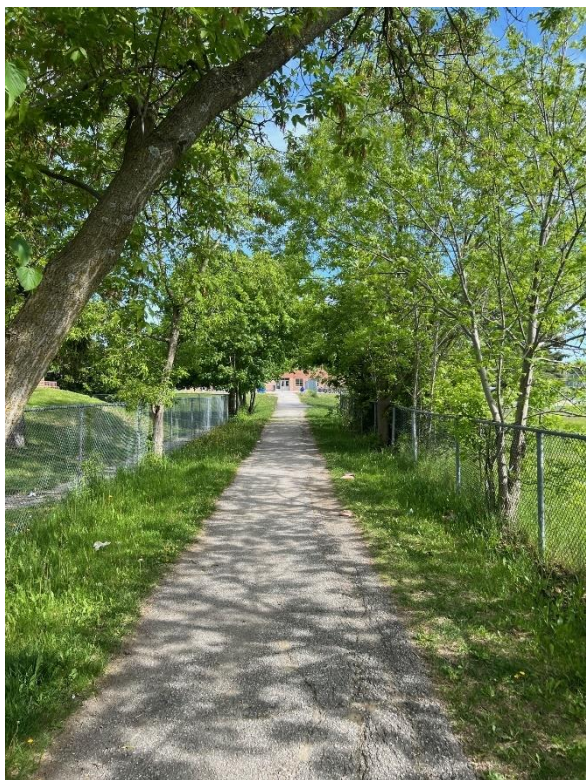
Photo # 3- Trees #28-29

| <b><u>Tree Tag No.</u></b> | <b><u>Reason for removal</u></b> |
|---|---|
| <b>28</b> | Grading within TPZ / Growing into existing fence |
| <b>29</b> | Grading within TPZ / Growing into existing fence |

| Tree No. | Botanical Name | Common Name | Diameter at 1.4m Height (cm) | Height (m) | Condition rating (P, F, G) | Crown Spread (m) | TPZ | Remarks | Final Tree Status (P,I,R)<br>-Preserve -<br>Injure -<br>Remove |
|---|---|---|---|---|---|---|---|---|---|
| 28 | Fraxinus pennsylvanica | Green Ash | 5 , 4 | 6 | F | 4 | 1.8 | In fence line | R |
| 29 | Fraxinus pennsylvanica | Green Ash | 17 | 6 | F | 4 | 1.8 | In fence line | R |

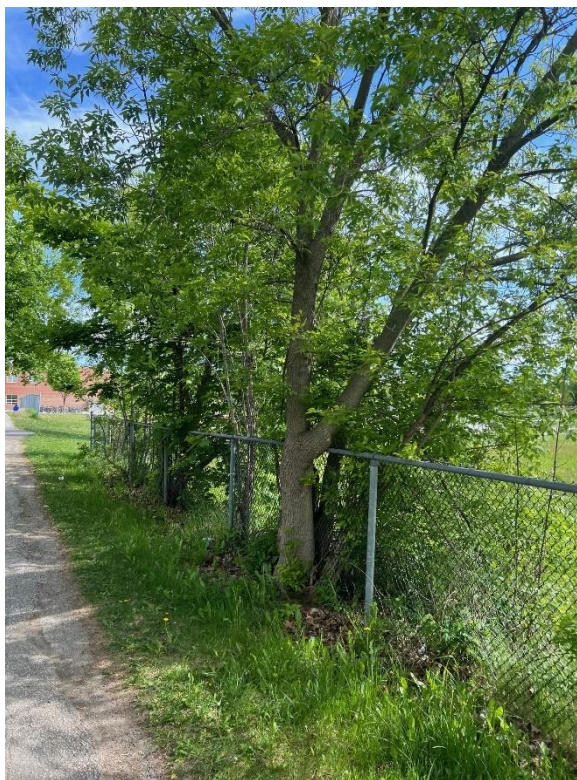
Photo # 4- Trees #26-27

| <b><u>Tree Tag No.</u></b> | <b><u>Reason for removal</u></b> |
|---|---|
| <b>26</b> | Grading within TPZ / Root Impacts / Growing into existing fence |
| <b>27</b> | Grading within TPZ / Invasive species / Growing into existing fence |

| Tree No. | Botanical Name | Common Name | Diameter at 1.4m Height (cm) | Height (m) | Condition rating (P, F, G) | Crown Spread (m) | TPZ | Remarks | Final Tree Status (P,I,R)<br>-Preserve -<br>Injure -<br>Remove |
|---|---|---|---|---|---|---|---|---|---|
| 27 | Acer negundo | Manitoba Maple | 35/17 | 8 | F | 7 | 2.4 | In fence line | R |

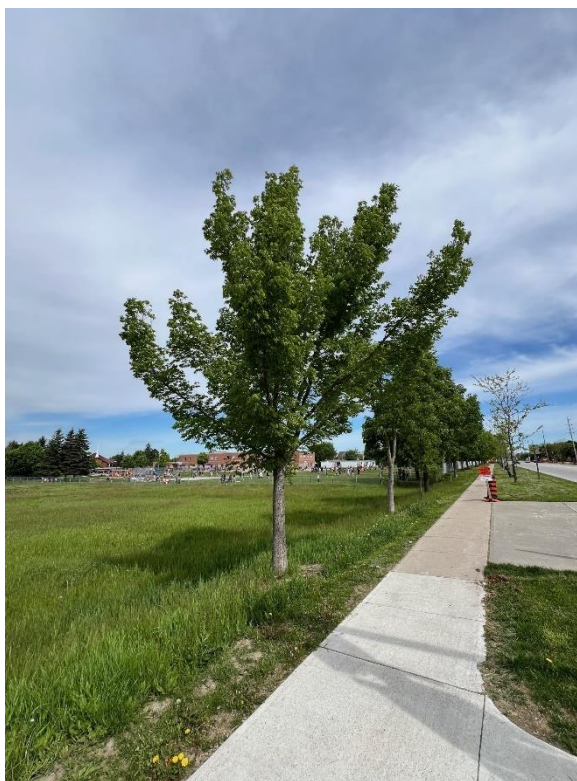
Photo # 6- Trees #32-33

| <b><u>Tree Tag No.</u></b> | <b><u>Reason for removal</u></b> |
|---|---|
| <b>32</b> | Grading within TPZ / Root Impacts |
| <b>33</b> | Grading within TPZ / Root Impacts |

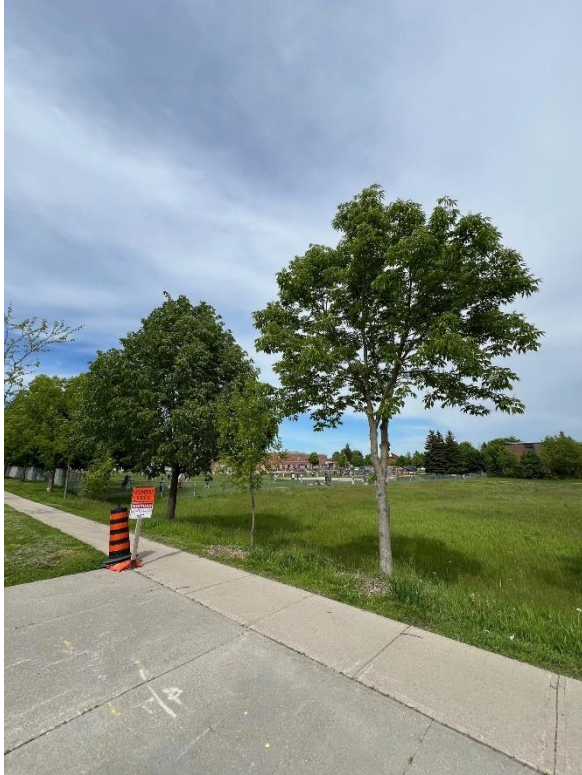
Photo # 7- Trees #34-35

| <b><u>Tree Tag No.</u></b> | <b><u>Reason for removal</u></b> |
|---|---|
| <b>34</b> | Grading within TPZ / Root Impacts |
| <b>35</b> | Grading within TPZ / Root Impacts |

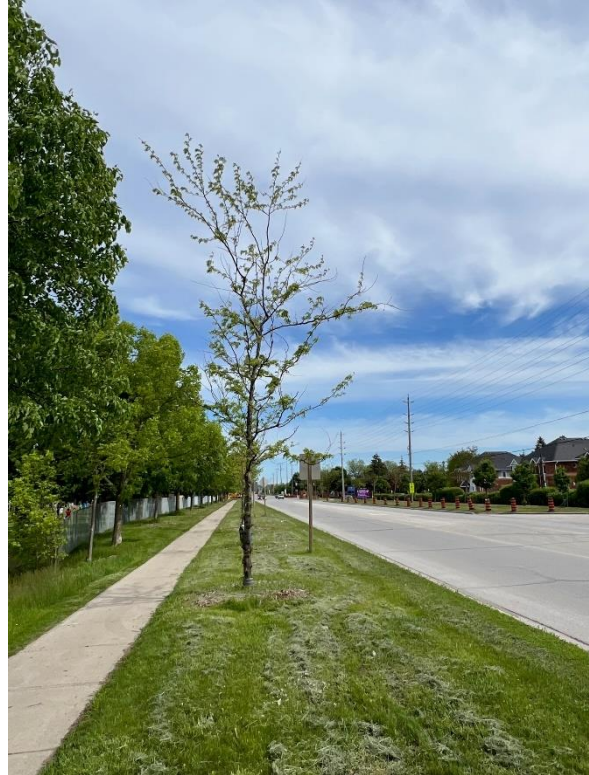
Photo # 8- Trees #36 & D

| <b><u>Tree Tag No.</u></b> | <b><u>Reason for removal</u></b> |
|---|---|
| <b>36</b> | Grading within TPZ / Root Impacts / Conflicts with proposed drive aisle |
| <b>D</b> | Grading within TPZ / Root Impacts / Conflicts with proposed drive aisle |

| Tree No. | Botanical Name | Common Name | Diameter at 1.4m Height (cm) | Height (m) | Condition rating (P, F, G) | Crown Spread (m) | TPZ | Remarks | Final Tree Status (P,I,R)<br>-Preserve -<br>Injure -<br>Remove |
|---|---|---|---|---|---|---|---|---|---|
| 36 | Gleditsia triacanthos | Thornless Honeylocust | 10 | 7.5 | F | 3.5 | 1.8 | Deadwood present | R |

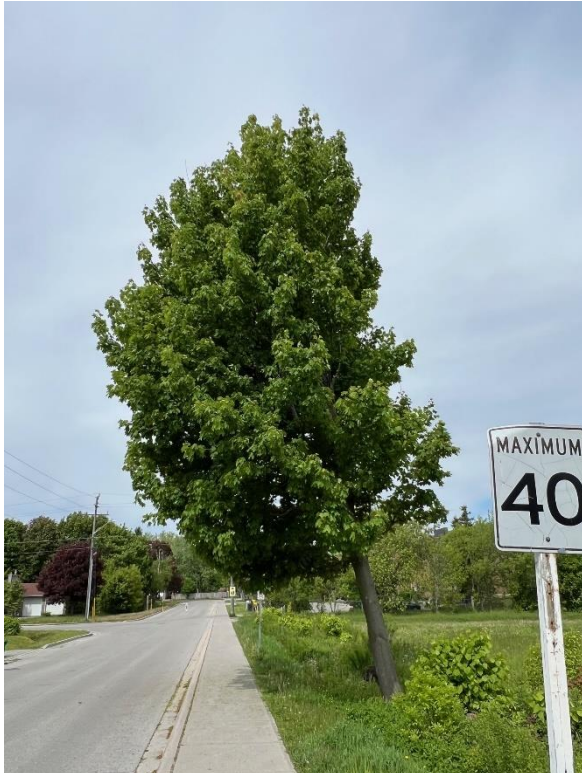
Photo # 9- Tree #31

| <b><u>Tree Tag No.</u></b> | <b><u>Reason for removal</u></b> |
|---|---|
| <b>31</b> | Grading within TPZ / Root Impacts / hazardous lean |

| Tree No. | Botanical Name | Common Name | Diameter at 1.4m Height (cm) | Height (m) | Condition rating (P, F, G) | Crown Spread (m) | TPZ | Remarks | Final Tree Status (P,I,R)<br>-Preserve -<br>Injure -<br>Remove |
|---|---|---|---|---|---|---|---|---|---|
| 31 | Acer platanoides | Norway Maple | 43 | 18 | F | 11 | 3 | Leaning to the south | R |

| Public Tree # | Species | DBH (cm) | Tree Removal Compensation |
|---|---|---|---|
| 31 | Freeman Maple (Acer x freemani) | 43 | \$4,740 |
