PHASE ONE ENVIRONMENTAL SITE ASSESSMENT FOR VACANT PROPERTY 35 GORDON COLLINS DRIVE, GORMLEY, ONTARIO

Fairpark Homes (1065752 Ontario Inc.)

Report No.: 230082-E1 August 21, 2023

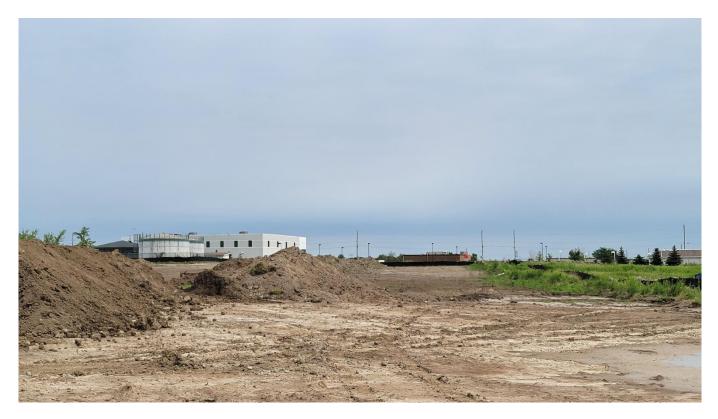
The site was recently stripped of surficial topsoil throughout the entire property. No signs of any staining were observed.

Photograph 1: Facing east in the middle of the property showing the site being stripped of topsoil recently.

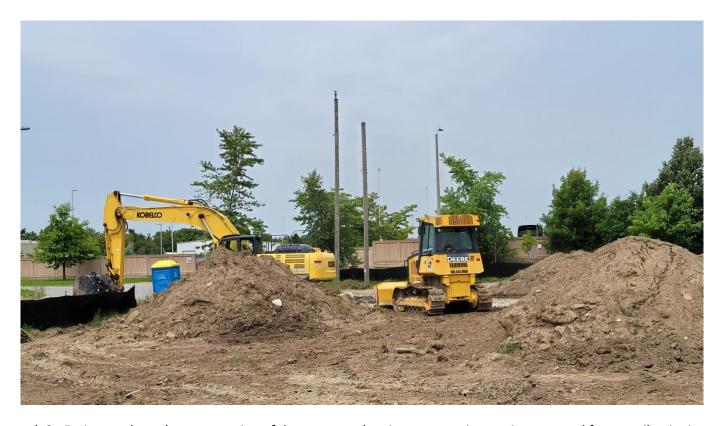
Photograph 2: Facing north on the west portion of the property showing construction equipment used for topsoil stripping.

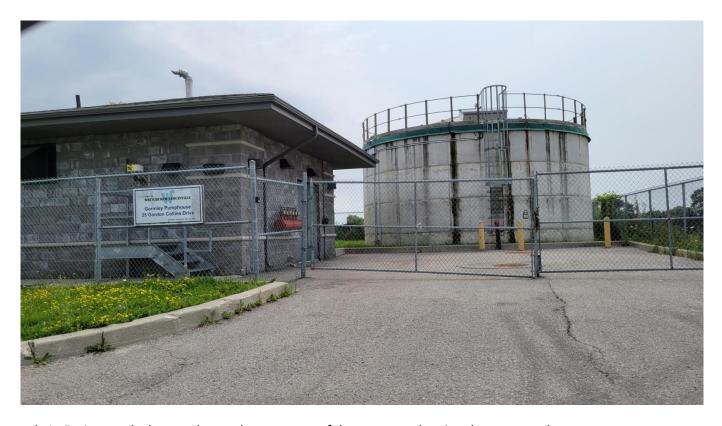
Photograph 4: Facing south close to the northeast corner of the property showing the water tank.

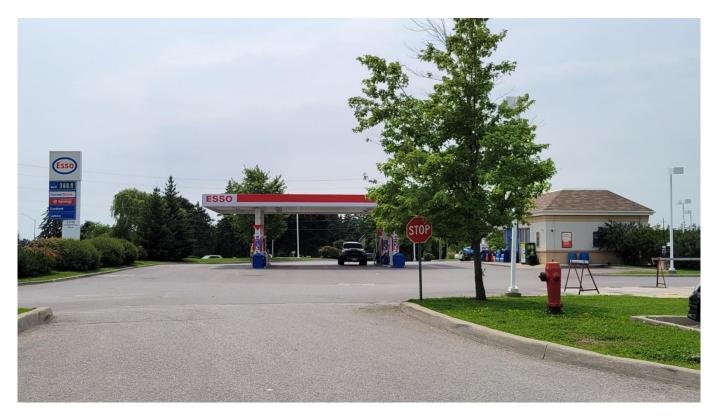
Potentially Contaminating Activity	Description
PCA 10: Commercial Autobody Shops PCA 28: Gasoline and Associated Petroleum Products in Fixed Tanks	There are a gasoline service station and an truck repair shop located on the southeast and north of the Phase One property. These off-site PCAs are generating two APECs on the property

Photograph 5: Facing south on Woodbine Avenue showing the gasoline station at 2210 Stouffville Road.

Based on the findings of the Phase I ESA, a Phase II ESA is recommended to address potential contaminant impacts on the Phase One property. A Phase II ESA should be carried out around the south and southeast portions of the Phase One property and soil and groundwater samples should be taken and submitted for testing for the presence of Metals and Inorganics and Petroleum Hydrocarbons (PHC), BTEX / F1

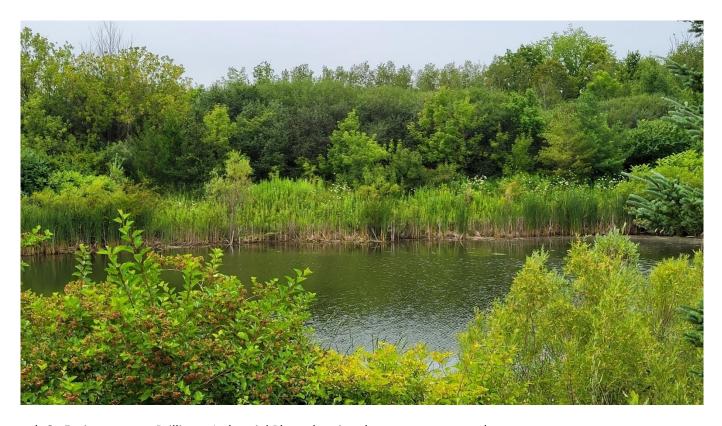
Photograph 6: Facing west on Brillinger Industrial Place showing the stormwater pond.
