September 13, 2023

Report No. 230082-E2

Fairpark Homes (1065752 Ontario Inc.)
2561 Stouffville Road
Gormley, Ontario
L0H 1G0

**PHASE TWO ENVIRONMENTAL SITE ASSESSMENT
35 GORDON COLLINS DRIVE, GORMLEY, ONTARIO**

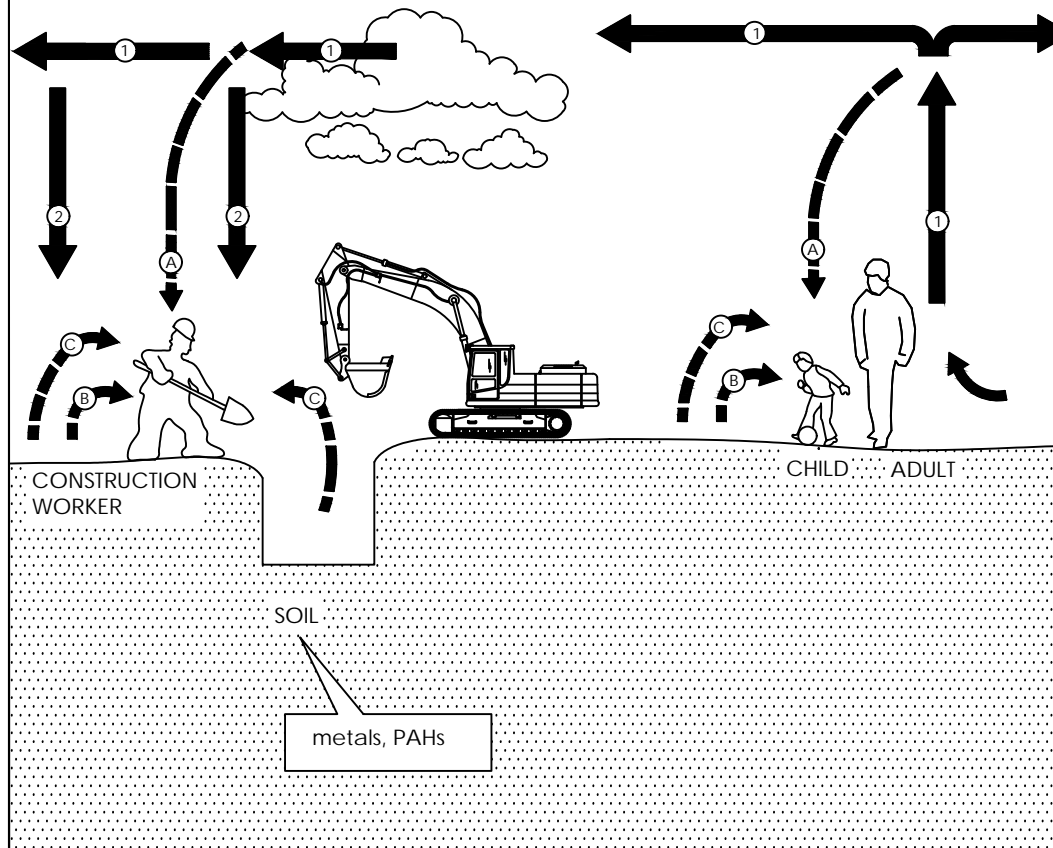
CONCEPTUAL MODEL FOR HUMAN RECEPTORS:

- ① AIR DISPERSION EVAPORATION INTO ATMOSPHERE
- ② PRECIPITATION OF RAIN, SNOW ICE & DEW, ETC.

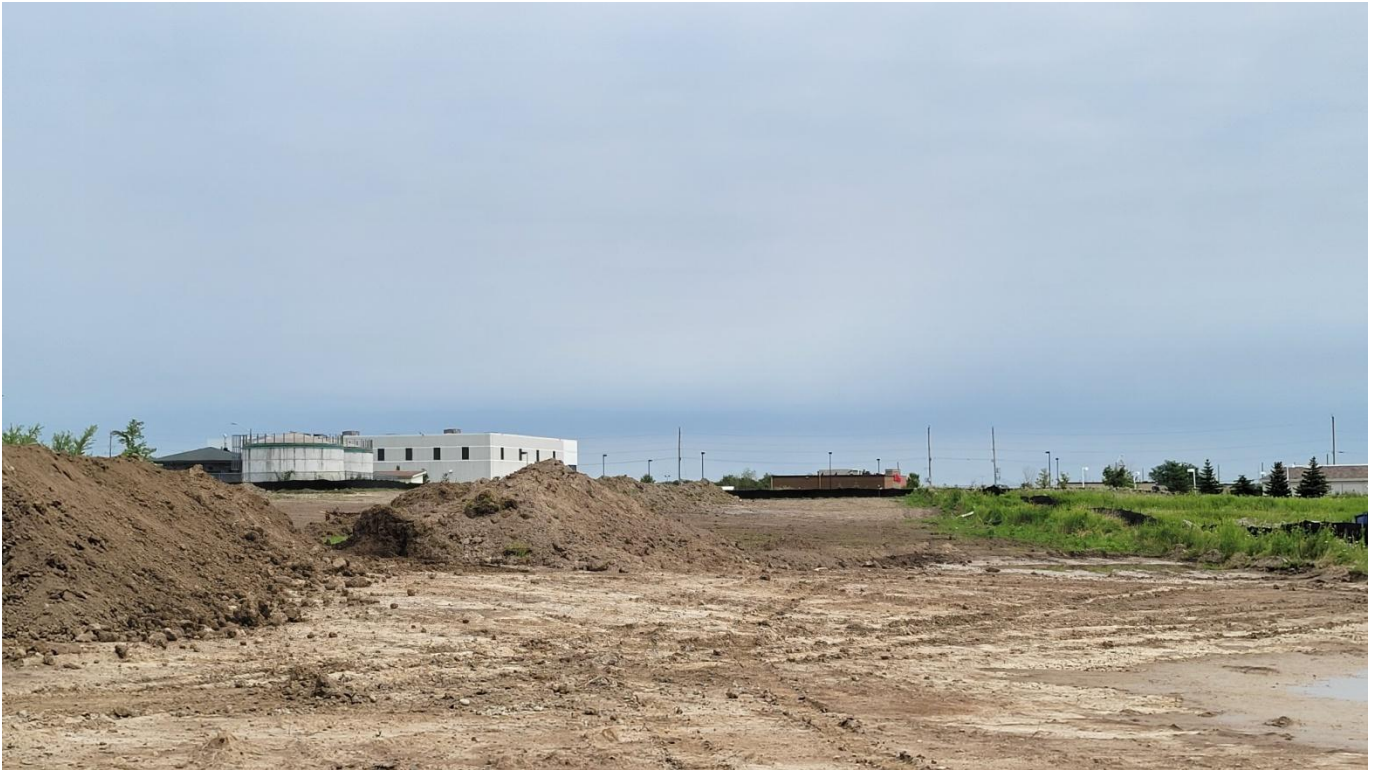
Photograph 1: Facing east in the middle of the property showing the site being stripped of topsoil recently.

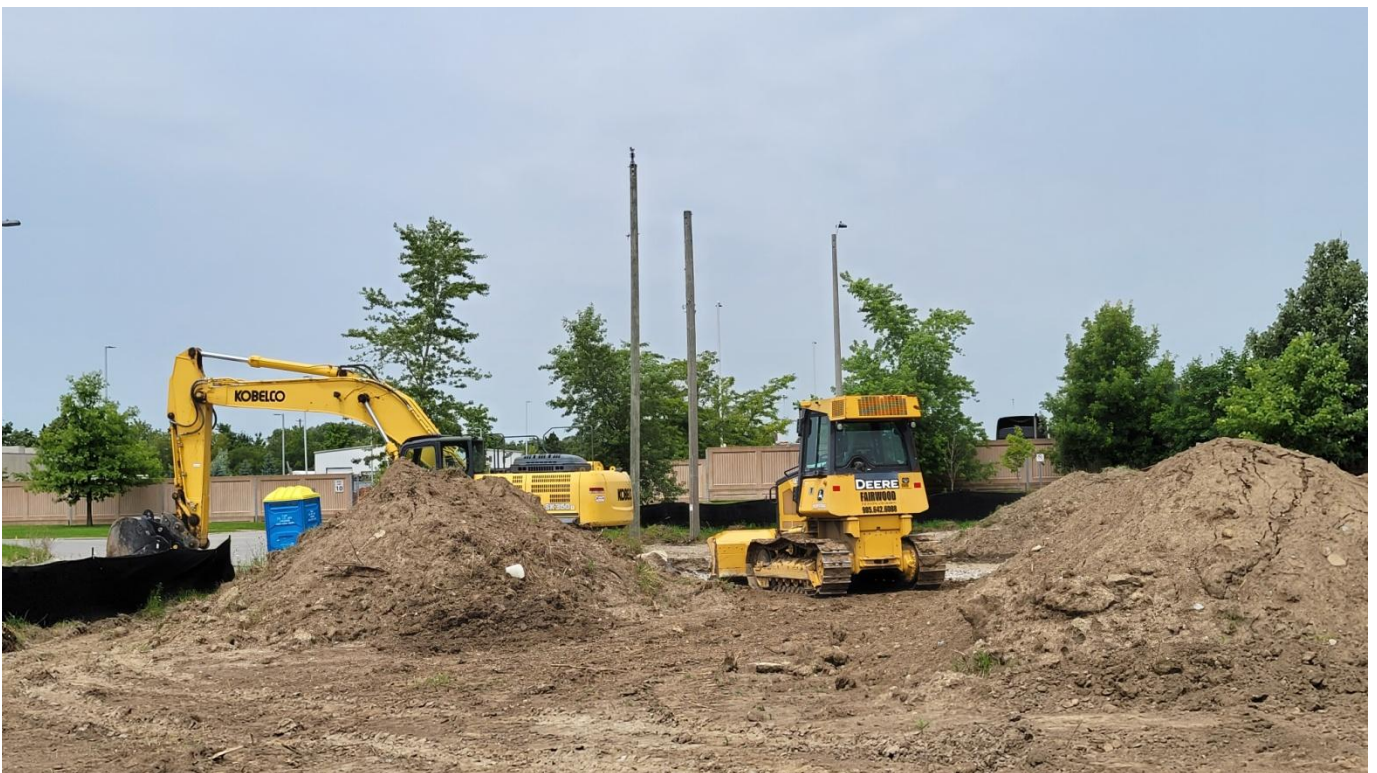
Photograph 2: Facing north on the west portion of the property showing construction equipment used for topsoil stripping.

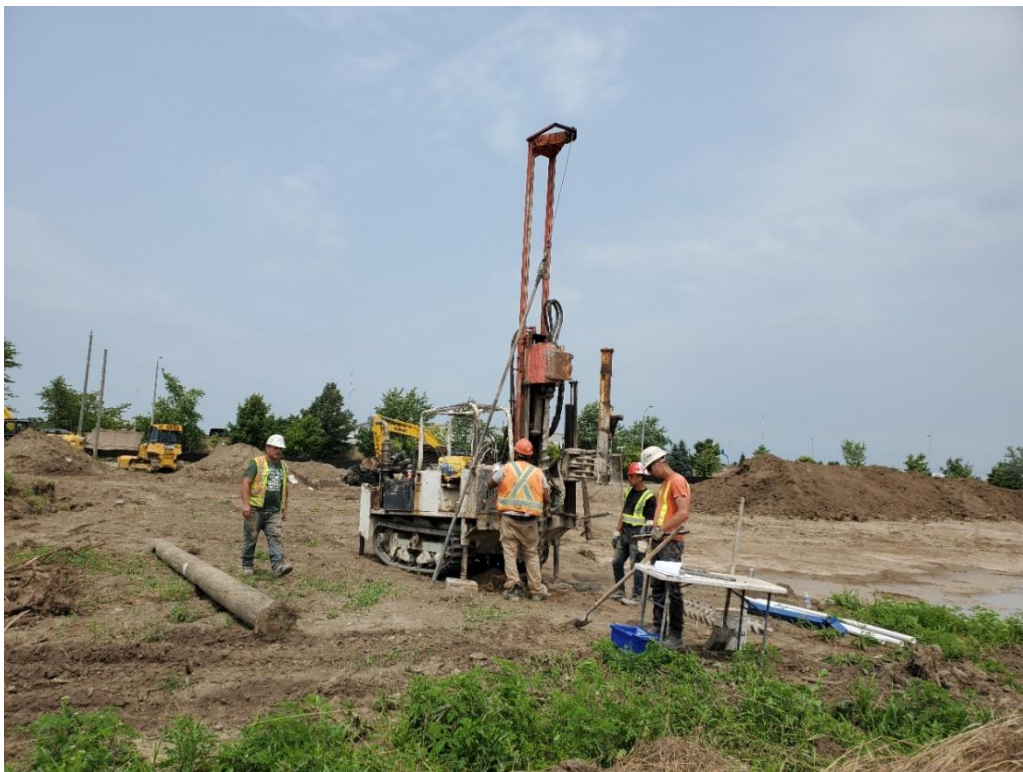
Photograph 3: Facing north on the southwest portion of the property showing borehole drilling during the Phase II investigation.

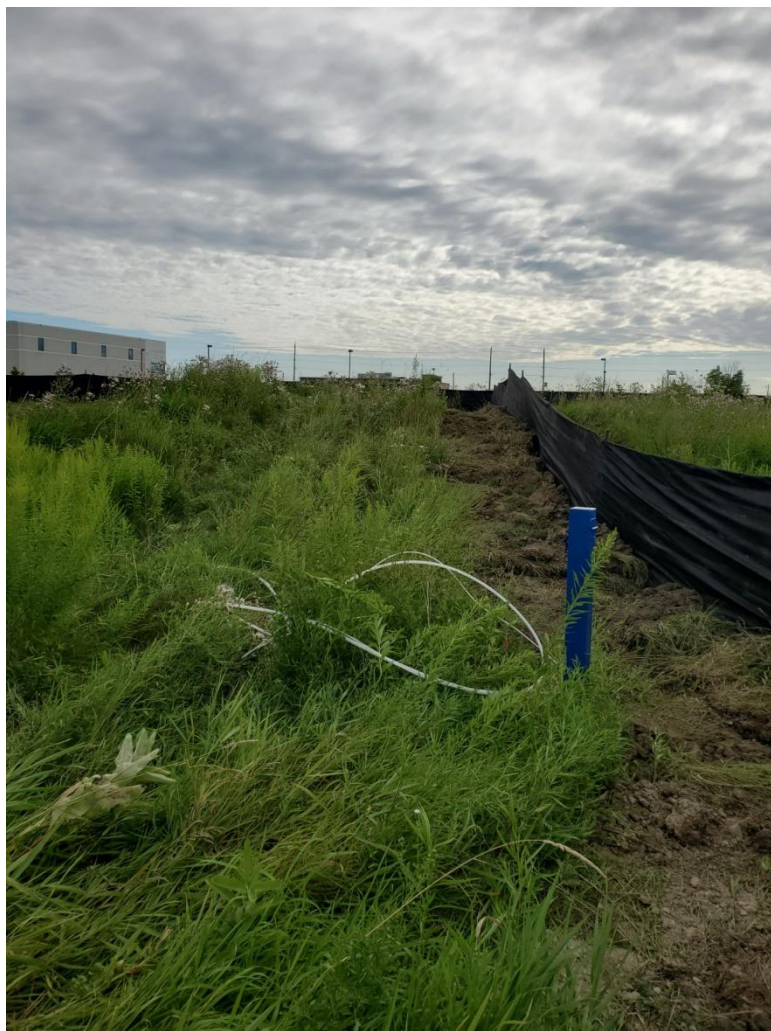
Photograph 4: Facing east on the southeast portion of the property showing an installed monitoring well.
