5688 Main Street, Stouffville, Ontario

Hydrogeological Investigation and Water Balance Assessment

BRM-23014306-A0

2024-12-13

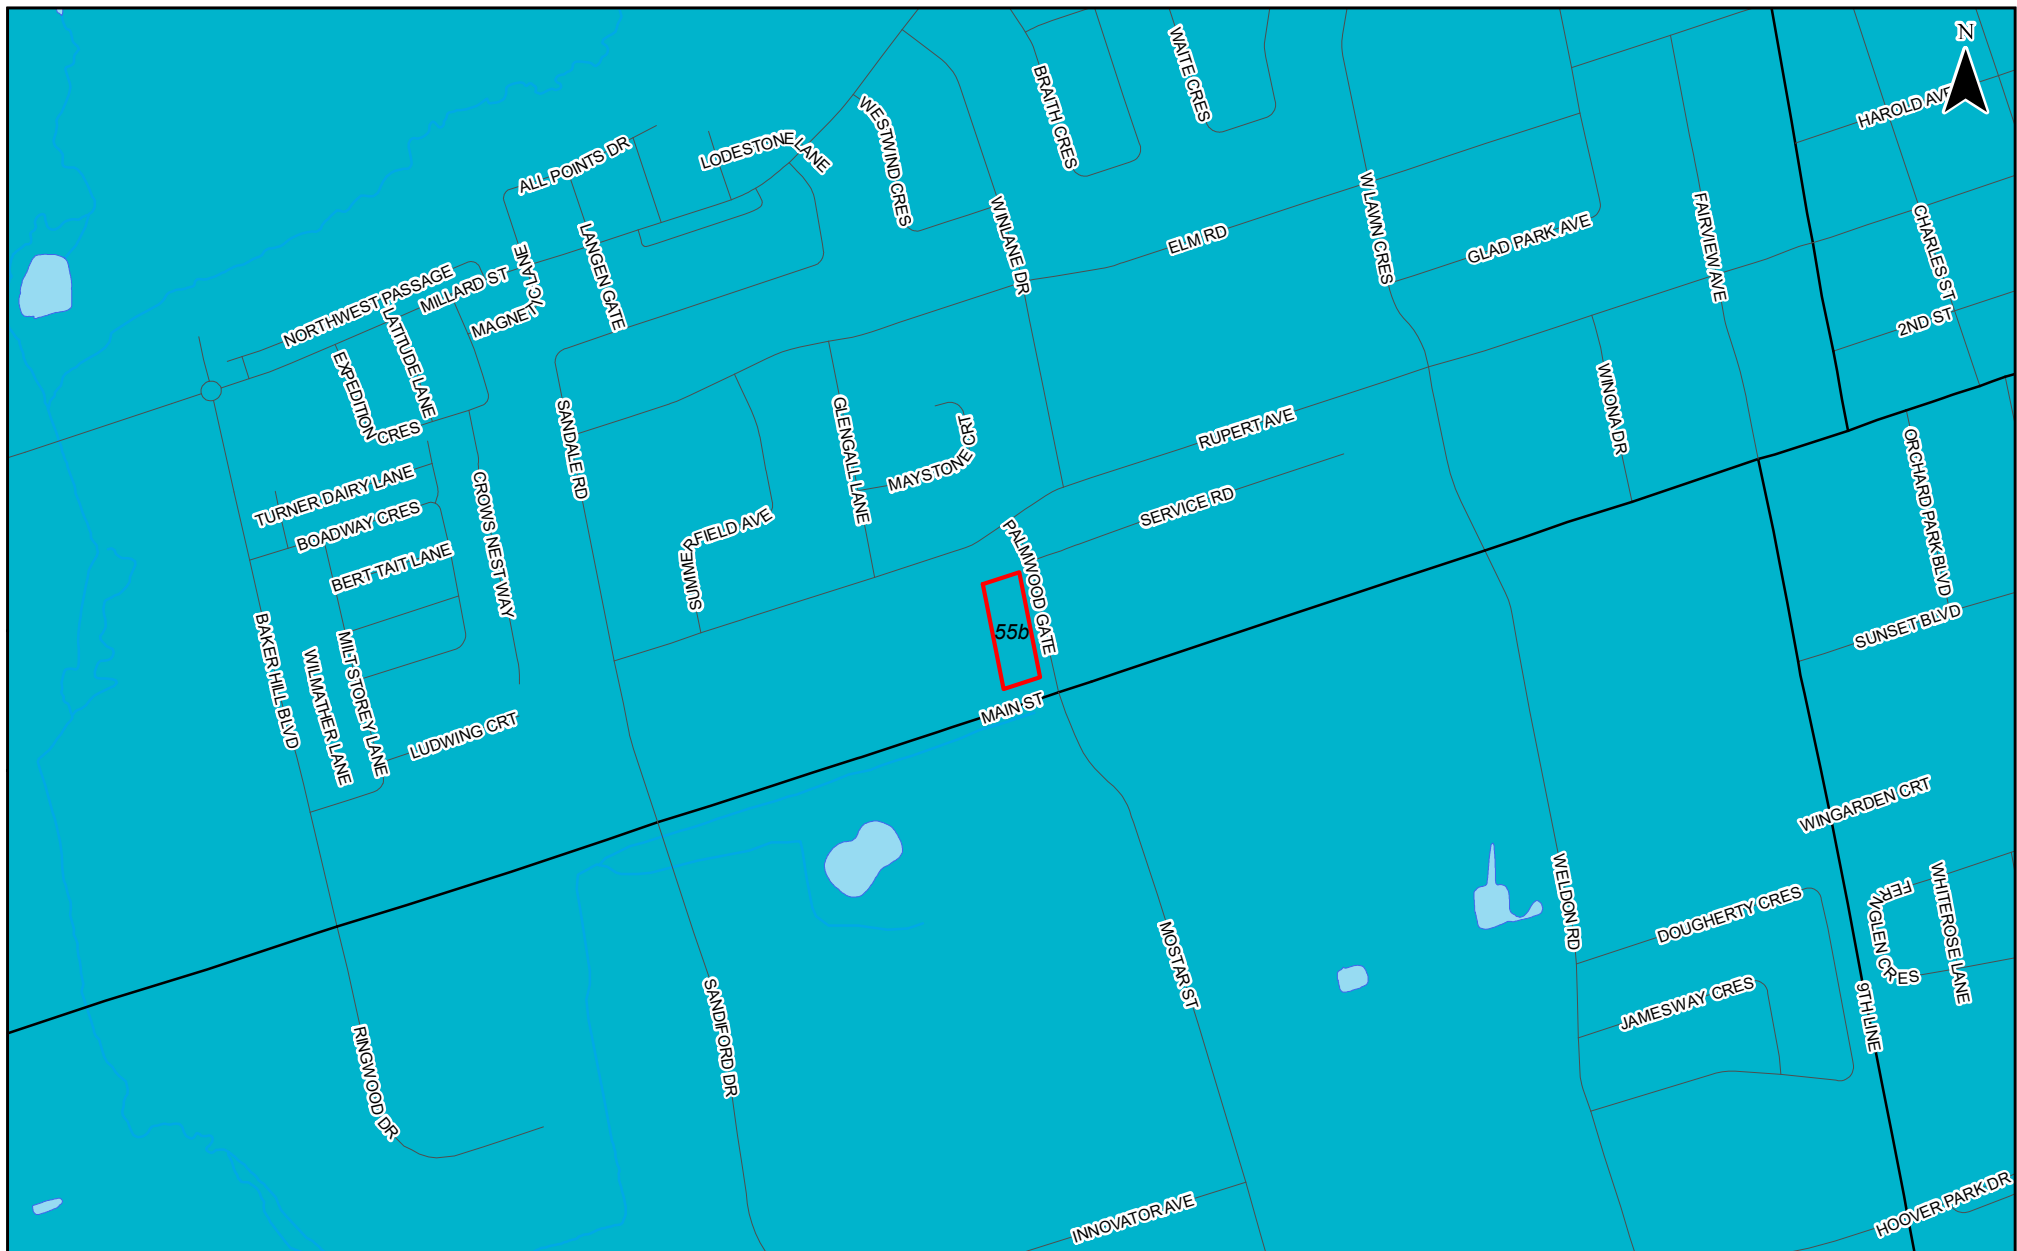
SOURCE:
BASED ON ONTARIO GEOLOGICAL SURVEY DATA PUBLISHED IN 2011

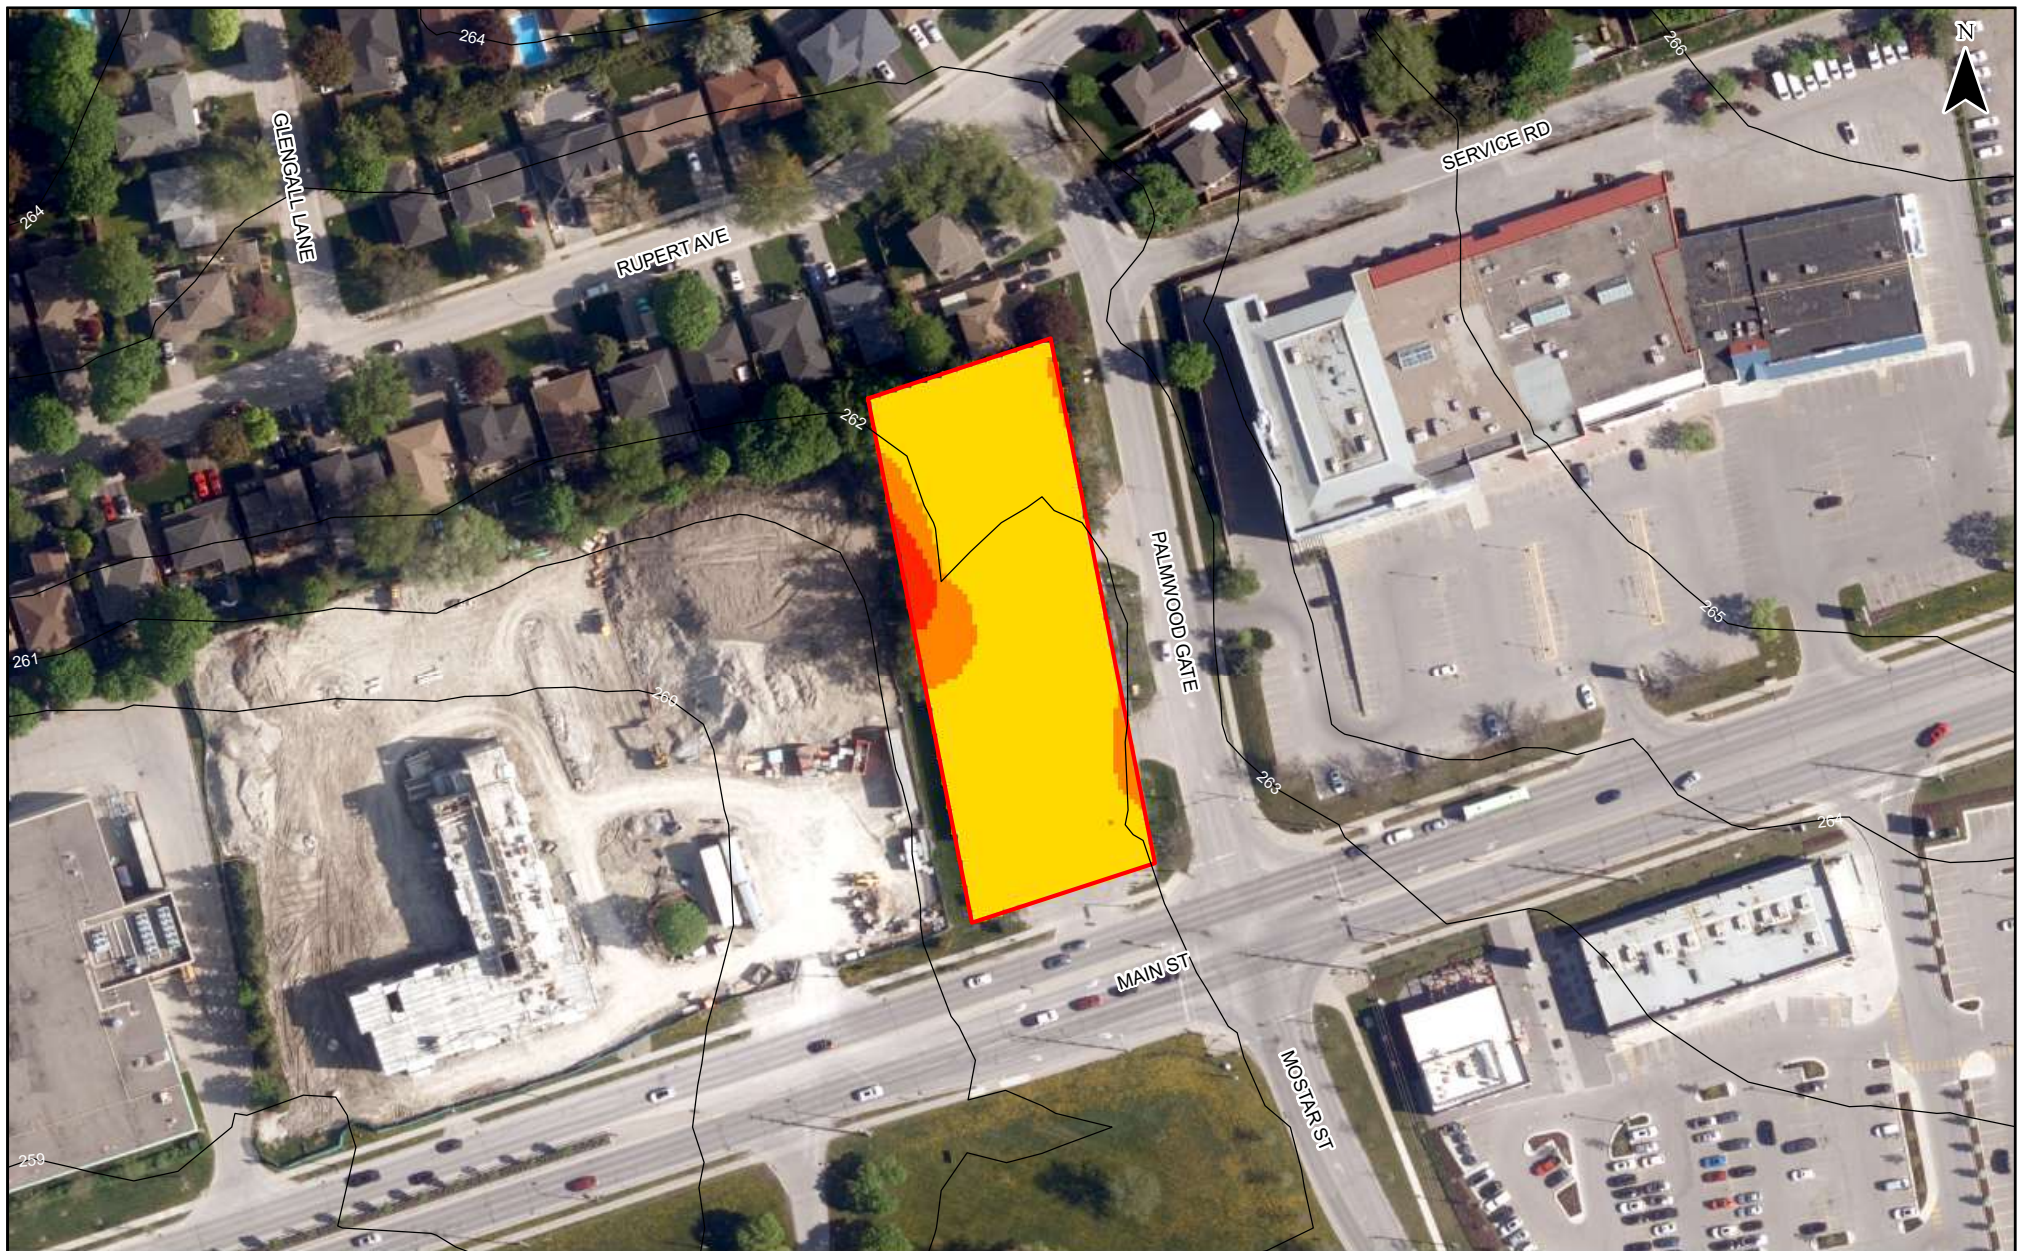
SOURCE:
TOPOGRAPHIC CONTOURS BASED ON
PUBLIC SECTOR INFORMATION MADE AVAILABLE UNDER
THE REGIONAL MUNICIPALITY OF YORK'S OPEN DATA LICENCE.

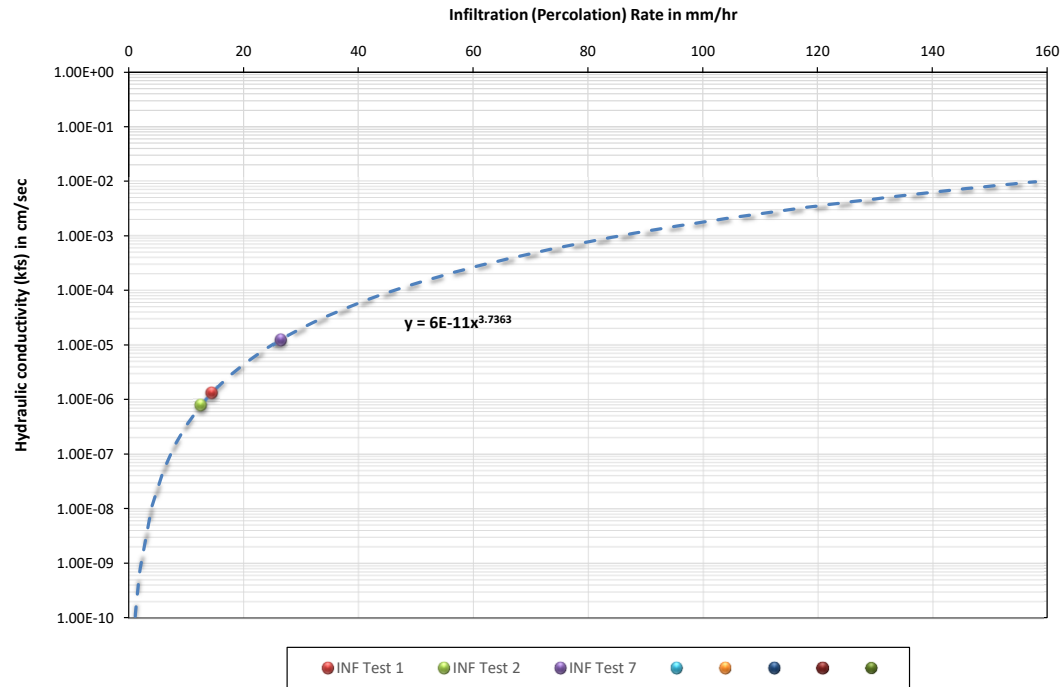
Kfs: hydraulic conductivity (cm/sec)
IR: infiltration rate (mm/hr)
DIR: design infiltration rate (mm/hr)
SCF: Safety Correction Factor (based on the chart recommended by CVC and TRCA, 2010)

**Figure : Approximate relationship between infiltration rate and hydraulic conductivity
(LID SWM planning and Design Guide, Appendix C1)**
