Phase I Environmental Site Assessment  
15374 and 15450 Woodbine Avenue, Gormley, Ontario

Final Report

Phase I Environmental Site Assessment (ESA)

BRM-21010864-A0

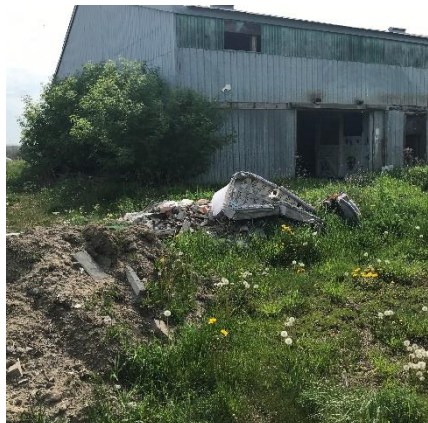
**Photograph No. 11**  
**View of fill piles northwest of Barn**

Several small piles of soil and rubble were observed to the west of the Barn and behind the gates at the northeast corner of the Site. No other berms or stockpiles were observed.

Given the small quantity, the presence of several small piles of soil and rubble observed to the west of the Barn was not considered to present a significant potential environmental concern for the Site. However, during future construction or redevelopment of the Site, it is recommended that the soil piles be characterized via a sampling and testing program prior to being reuse or remove from the Site for disposal.

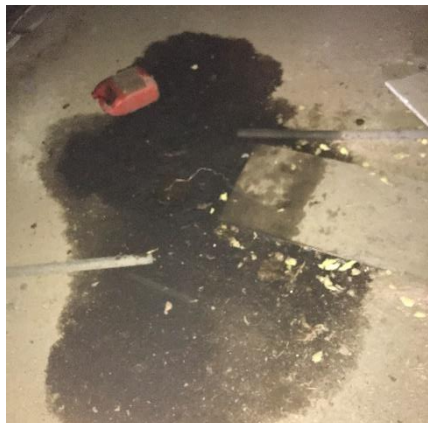
**Photograph No. 17**  
**View of staining in enclosure at northeast portion of Barn**

Petroleum staining at northeast portion of the Barn	Soil / Groundwater BTEX, PHCs	Evidence of petroleum staining on concrete floor was identified in the existing Barn/Stable. There is a potential for subsurface impact in the vicinity of the drain in a washing area at the existing Barn/Stable, from unverified housekeeping and material storage practices in the past. As such, further investigation is considered warranted.
Potential historic use of oil-based suppressant on dirt tracks and/or corrals	Soil PCBs, BTEX, PHCs	Part of the Site appears to have been used as an equestrian facility with several corrals outside the Barn. It was a common practice to apply oil-based dust suppressant on dirt tracks or corrals in the past which presents a potential concern. As such, the potential environmental concern associated with historic usage of oil-based dust suppressants at the dirt tracks and/or corrals on Site warrants further investigation.

An empty container of motor oil with a small area of staining in its vicinity was observed on the concrete floor at the northeast section of the Barn. There were no drains near the stained area and the stained concrete floor was observed to be in good condition with no evidence of cracks. No other areas of significant staining were observed at the Site at the time of the Site visit.

Based on the findings of the Phase I ESA, further environmental investigation (i.e., Phase II ESA) is recommended for the Site.

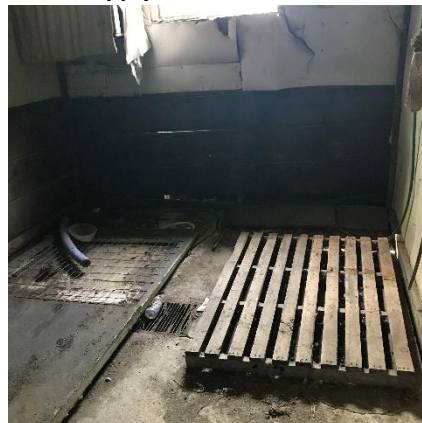
**Photograph No. 18**  
**View of drain in enclosure at northeast portion of Barn**

A drain was observed in an interior enclosure in the northwest corner of the Barn. No other drains or sumps were noted at the time our Site visit.
