Tree Inventory and Arborist Report

5688 Main St, Whitchurch-Stouffville, ON L4A 7Z9

Tree Inventory – 5688 Main Street, Whitchurch-Stouffville ON L4A 2T1 – April 5 2024.

**TREE INVENTORY,
PRESERVATION &
REMOVALS PLAN**

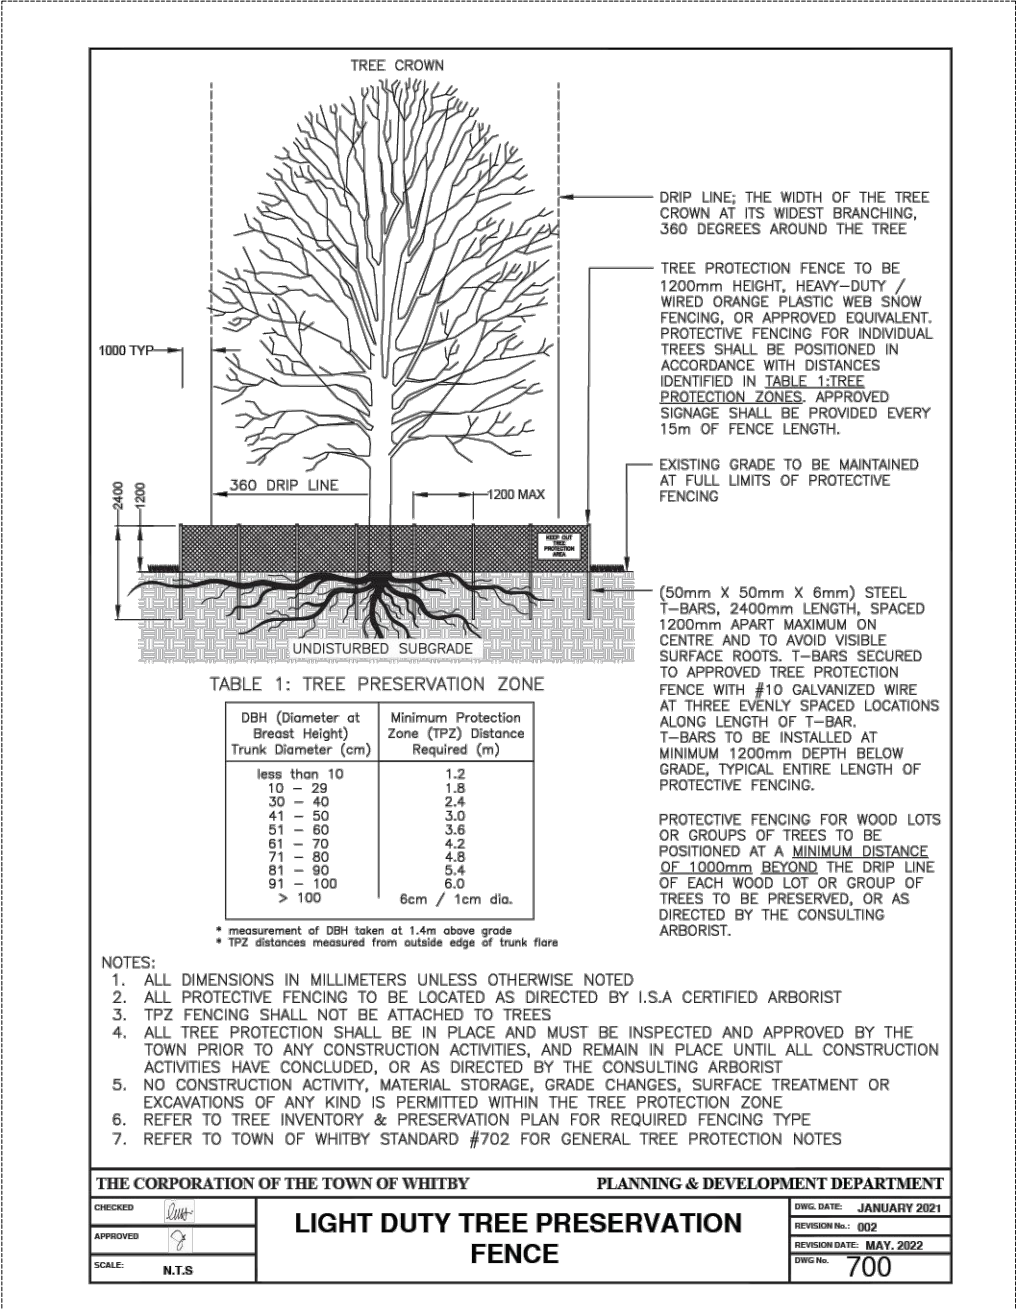
TREE PROTECTION FENCE
TP-1
NTS

TOTAL # OF TREES INVENTORIED = 37
TOTAL # OF TREES TO BE REMOVED = 33
TOTAL # OF TREES TO REMAIN = 4

ALL PRUNING OF ROOTS AND BRANCHES SHALL BE CONDUCTED BY AN ISA CERTIFIED ARBORIST OR EQUIVALENT, OR UNDER SUPERVISION OF AN ISA CERTIFIED ARBORIST AND SHALL BE IN ACCORDANCE WITH GOOD ARBORICULTURAL STANDARDS AND PRACTICES. REFER TO ARBORIST REPORT PREPARED BY THE URBAN ARBORIST INC. DATED FEBRUARY 25TH, 2025.
