# TREE INVENTORY AND ASSESSMENT REPORT

## FARSIGHT HOMES - LAKESHORE ROAD

### BALLANTRAE, ON

**April 6, 2021**  
SCI Project No. 16050

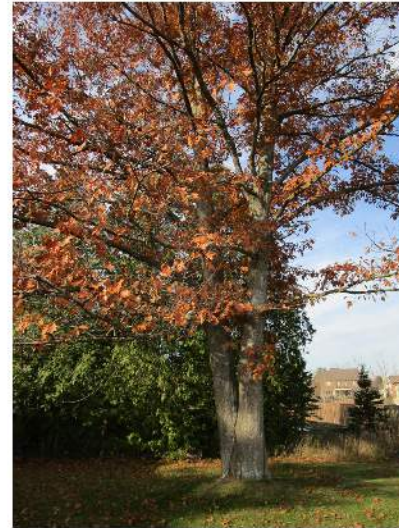
Tree 3

| Tree No. | Tag No. | Species | | Condition | | DBH (single stem)** | DBH Range of Multi-stemmed Trees (# of Stems) | Ownership Categories **** | Notes | Recommendations* |
|---|---|---|---|---|---|---|---|---|---|---|
| 3 | 1002 | Quercus rubra | Red Oak | Good | Good | 81.5 | - | Private 1 | Minor vertical frost crack | A |

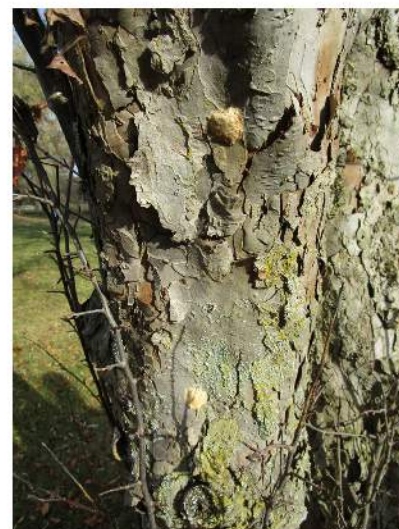
Tree 11 - gypsy moth eggs

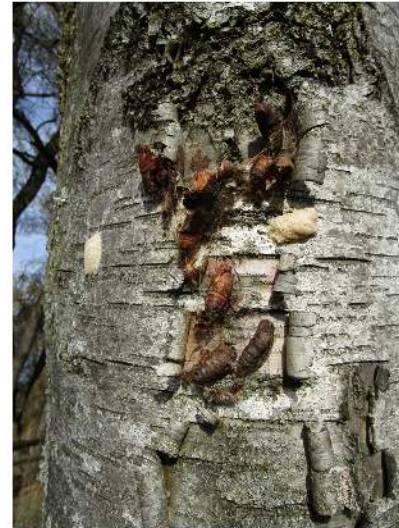
Tree 16 - gypsy moth eggs & cocoons

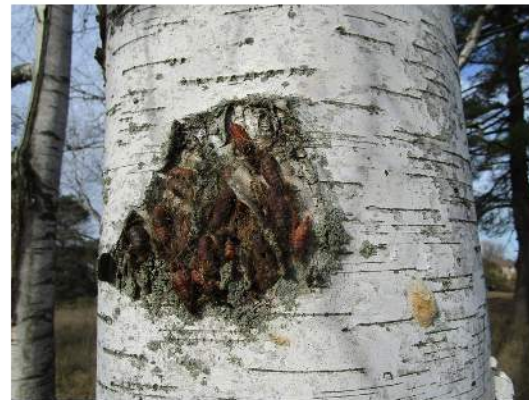
Tree 20 - gypsy moth eggs & cocoons

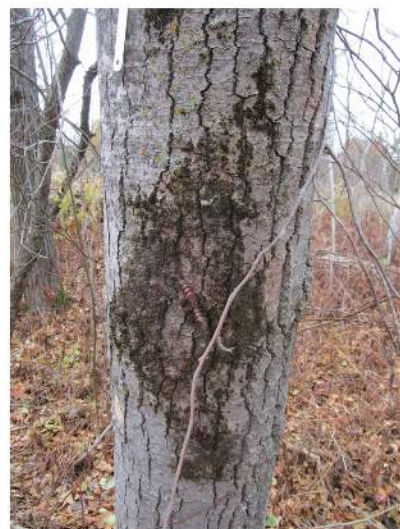
Tree 142 - gypsy moth cocoons

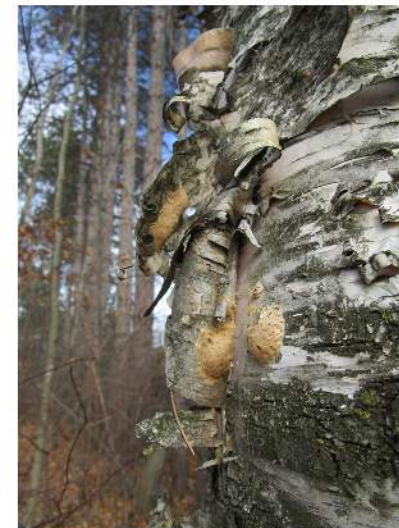
Tree 266 - gypsy moth eggs
